# WIADOMOŚCI KONSERWATORSKIE

JOURNAL OF HERITAGE CONSERVATION

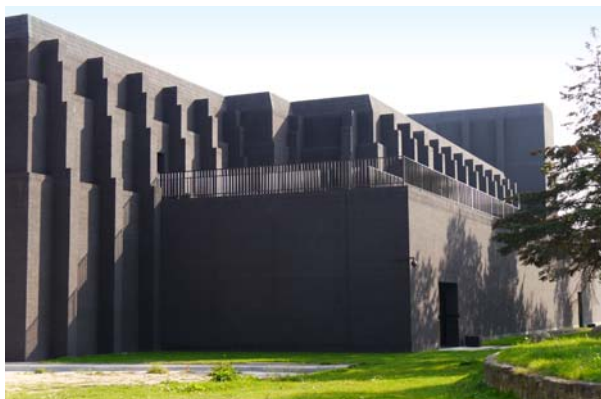
Ryc. 1. Widok z zewnątrz na Szekspirowski Teatr w Gdańsku z przyporami od strony południowej, fot. autor

Fig. 1. Outside view of the Shakespeare Theatre in Gdańsk with buttresses from the south side, photo author

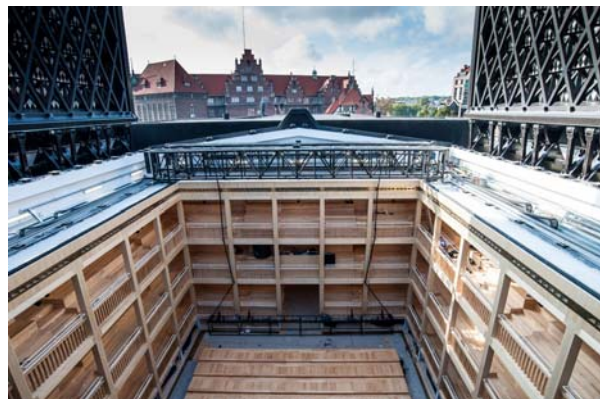
Ryc. 2. Otwierany dach został usytuowany ponad widownią, www.sztuka-architektury.pl

Fig. 2. The openable roof is located over the main room (the auditorium), www.sztuka-architektury.pl

A wide entrance on the north side leads onto the inner courtyard, further on we discover inner narrow passages resembling squares and alleys of a medieval city. We can use the stairs and ramps here to get onto the terrace on the roof of the theatre and see there the greatest secret of the building – an openable roof over the main room. “...the problem which had to be solved was not in fact related to the practical execution of an openable roof, but to the sense of ritual which was to be imbued into the very motion of opening...”<sup>14</sup>. When the roof is open, theatrical performances may take place in daylight, to some extent in the open air, like it used to be in the traditional English Shakespearean theatres. Here in Gdańsk, the complex metal-frame roof consists of two wings, 10.5 × 21 m in dimension, clad with copper sheets on the outside. The process of opening the roof lasts only 2 minutes, and its open wing, standing at the angle of 90° to the ceiling and roof plane, reaches the height of 23 metres. There are height limits set for the whole building by the city monument conservation officer due to the close vicinity of the Main City in Gdańsk. The very idea of an openable roof is explained by Renato Rizzi as not only a way of connecting with the traditional Shakespeare theatres but also as addressing the new history of the city. In an interview on his theatre design, he said: “...Solidarity was born in the

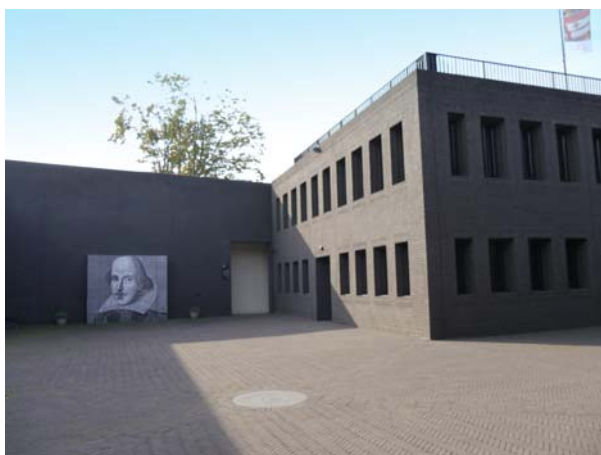
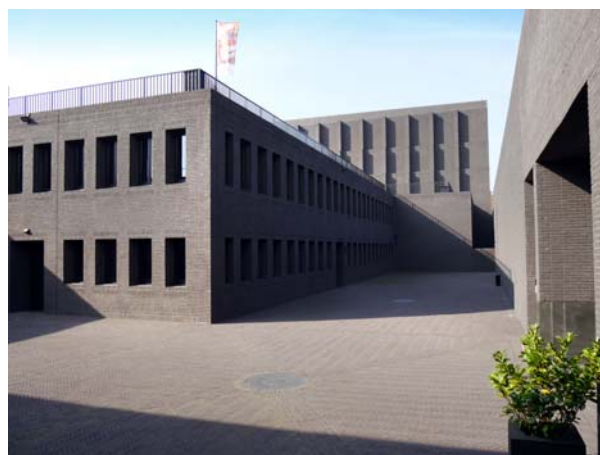
Ryc. 3–4. Szerokie wejście od strony północnej prowadzi na wewnętrzny dziedziniec, fot. autor

Fig. 3–4. The wide entrance on the north side leads onto the inner courtyard, photo author

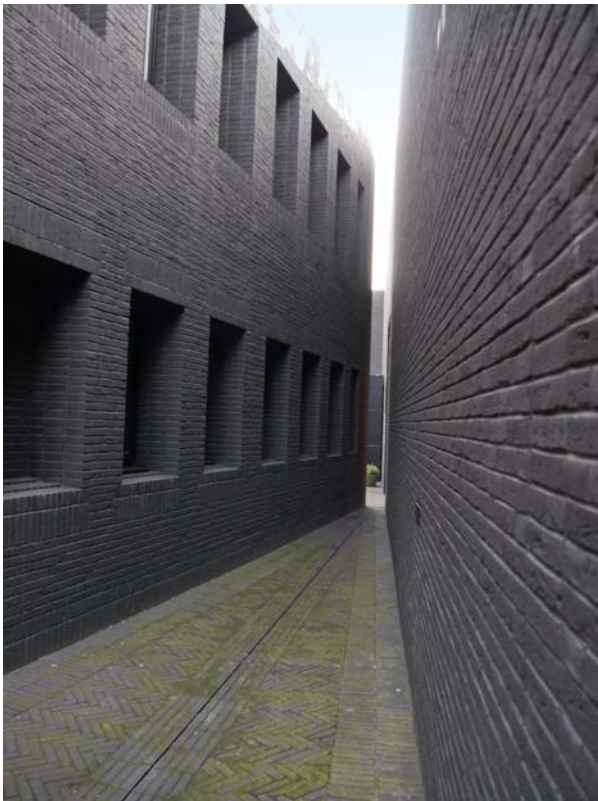
Ryc. 5. Wewnętrzne wąskie przejścia przypominają ulice średnio-wiecznych miast, fot. autor

Fig. 5. Inner narrow passages resembling streets of a medieval towns, photo author

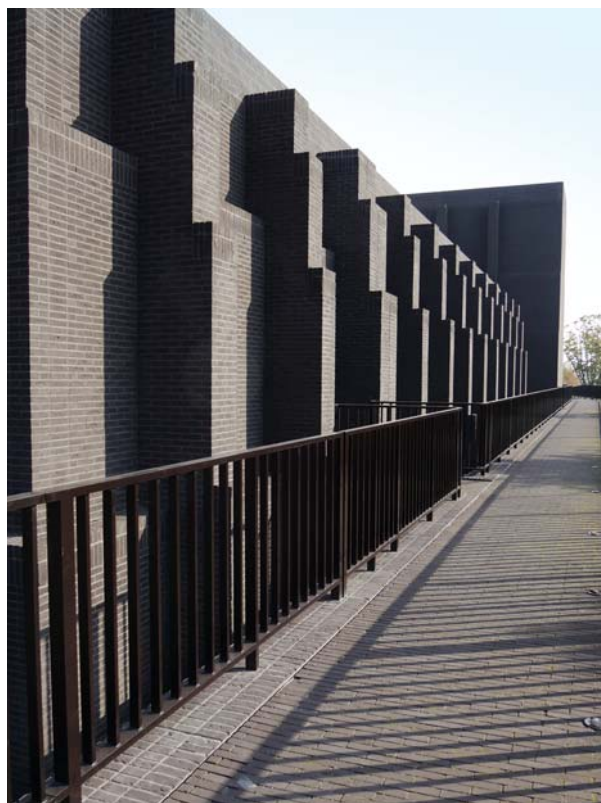
Ryc. 6–7. Rampy prowadzą na taras zlokalizowany na dachu, fot. autor

Fig. 6–7. The ramps lead on the terrace located on the roof, photo author

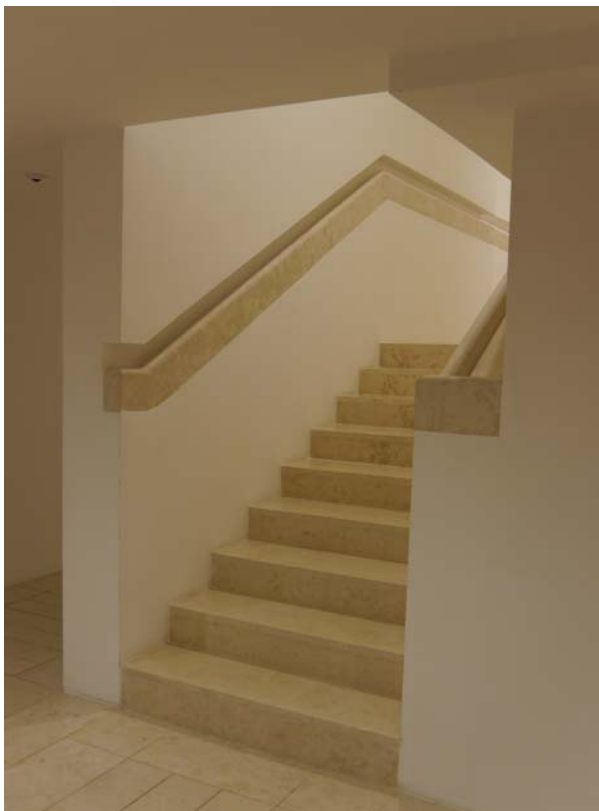
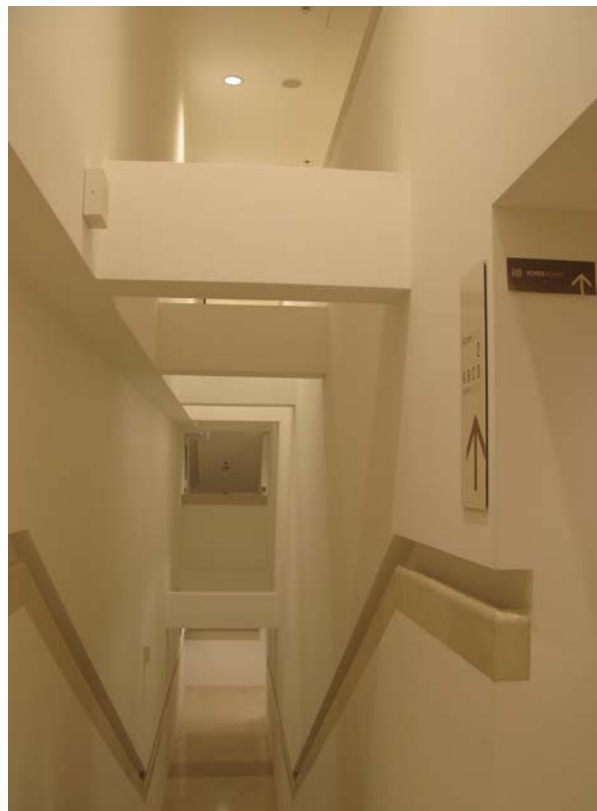
Ryc. 9–10. Wewnętrzne schody i korytarze, które są wykonane w jasnych barwach, fot. autor

Fig. 9–10. The inner stairs and corridors, which are executed in Wright tones. photo author

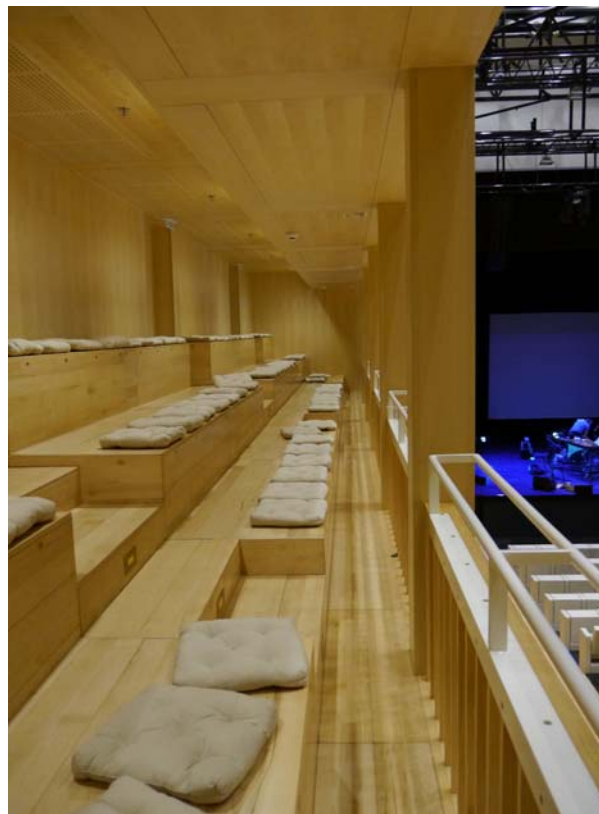
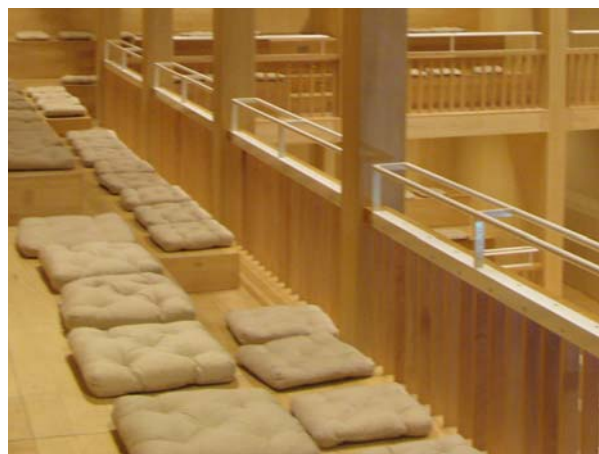
Ryc. 12–13. Detale galerii i balkonów widowni, fot. autor  
 Fig. 12–13. Details of the galleries and the balconies of the auditorium, photo author

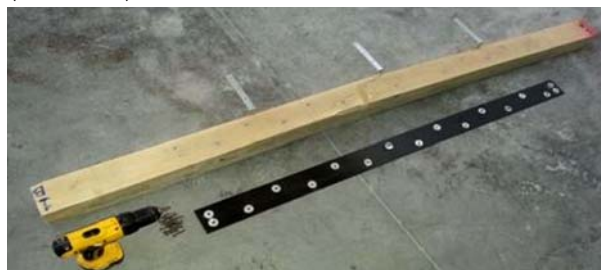
Fig. 1. Softwood beam and CFRP plate

The test program was divided into two series: bending tests on beams reinforced with unglued composite pultruded laminates and bending tests on beams repaired with basalt (BFRP) spikes. All beams were made of softwood (fir-wood) Tests were carried out on sharp-edged timber beams (Fig. 1) in fir wood (*Abies Alba*).

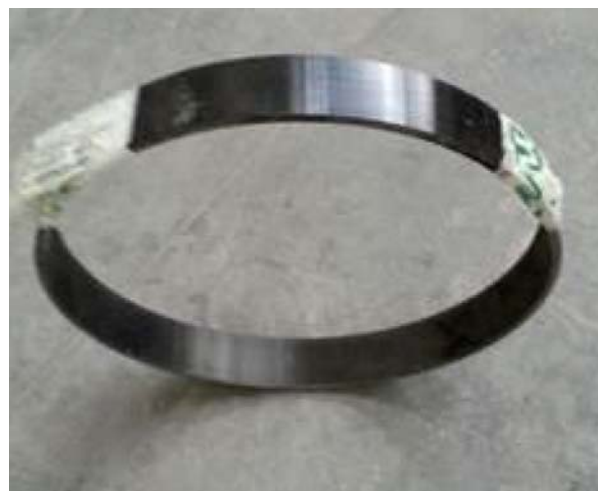
Fig. 2. CFRP plate

CFRP plates were reduced to a length of 1400 mm and symmetrically applied on the tension side of the timber beams. In order to avoid the use of polymeric adhesives to fix the CFRP to timber surface, steel screws and washers were used (Fig. 3). Plates were pre-drilled and a small quantity of epoxy resin was only inserted between the contact surface of the CFRP plate and steel washer in order to facilitate the stress transfer (Fig. 4).

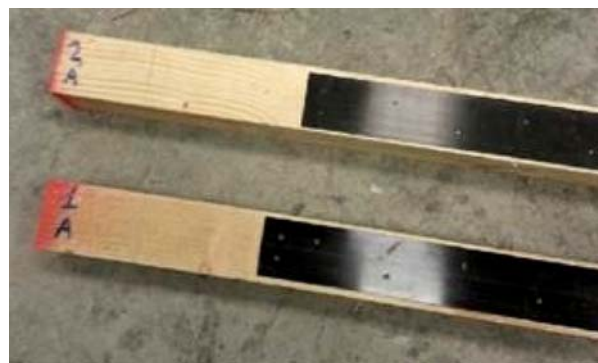
Fig. 3. Detail of application of the CFRP plate

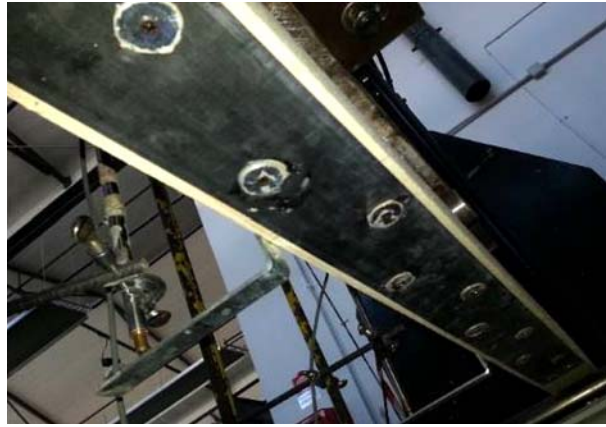
Fig. 5. CFRP plate applied on the timber tension side

For the geometrical arrangement of the screws, four configurations have been used. According to the first configuration, (screw layout No. 1 (Figs. 5 and 6a), screws were placed at a centre-to-centre distance of 200 mm. All screws were positioned 25 mm from plate's edges. Two screws were applied on both CFRP plate ends. For second configuration (screw layout No. 2 (Fig. 6b), screws were placed at a centre-to-centre distance of 100 mm.

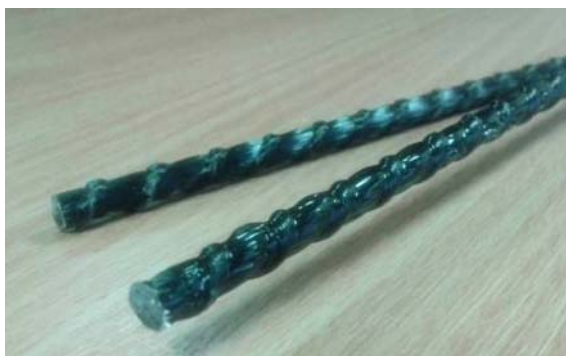
Fig. 7. BFRP spikes

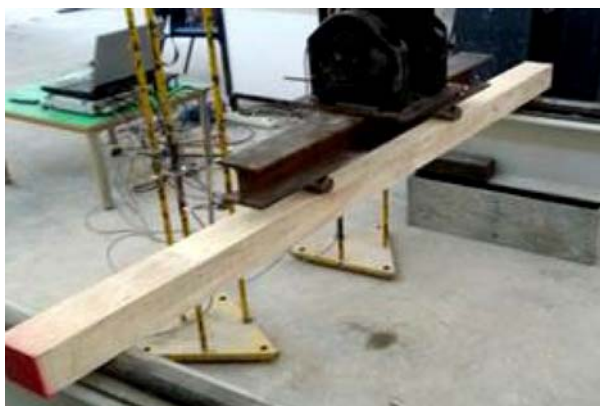
Fig. 10. Four-point-bending test

where  $l$  is the distance between the rollers;  $F_2 - F_1$  is an increment of load on the straight-line portion of the load deformation curve;  $w_2 - w_1$  is the increment of deformation corresponding to  $F_2 - F_1$ ;  $b$  is width of cross section. The test setup is shown in detail in Fig. 10.

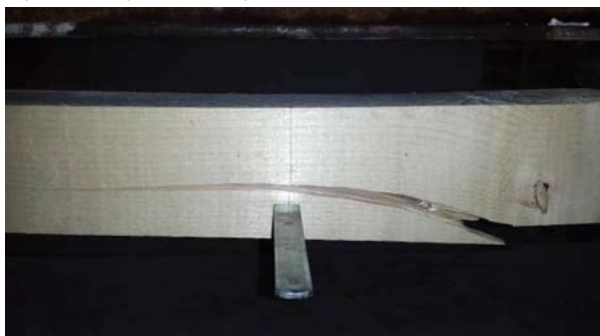
Fig. 11. Typical tensile failure mode of unreinforced beams near a knot or due to grain deviation

simple tension, cross grain tension, knot influenced (Fig. 11). Knots and grain deviation highly influenced the propagation of the cracks for all un-reinforced specimens. Deflection characteristics of the tested un-reinforced beams are shown in Table 4, the average bending strength was  $24.48 \text{ N/mm}^2$  (dev.  $8.31 \text{ N/mm}^2$ ) and the global modulus of elasticity  $5932 \text{ N/mm}^2$  (dev.  $907 \text{ N/mm}^2$ ).

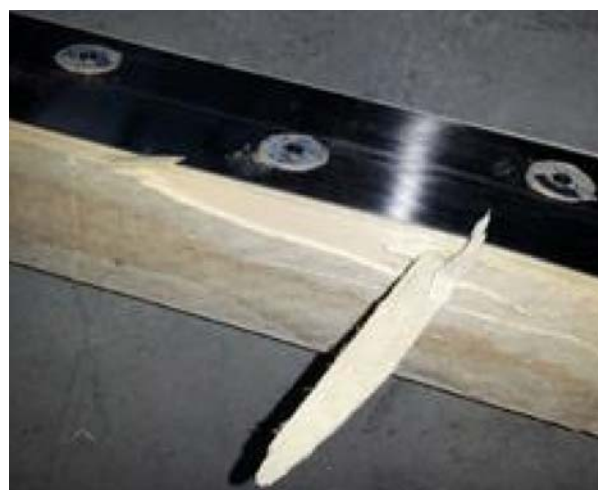
Fig. 14. Detail of the typical failure mode of reinforced beams

The test procedure was the same for all unreinforced and reinforced beams. For each of the 10 beam tests, graphs of mid-span deflection versus vertical load have been drawn. These are presented in Figure 13. Numerical results are reported in Table 5. It can be seen that the measured ultimate (maximum) load did not increase significantly after the application of the CFRP reinforcement. The most part of reinforced timber beams failed because of timber cracking on the tension side; it was also observed that CFRP plates did not fail (Fig. 13). For this reason a residual bending strength has been detected following timber cracking (Fig. 14).

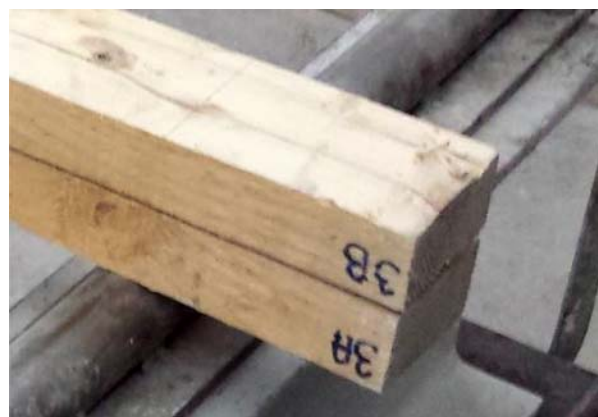
Fig. 15. Timber beams cut in half

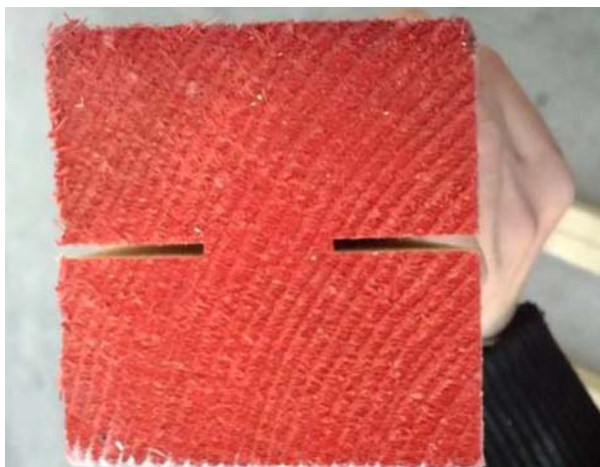
Fig. 16. Notched beams

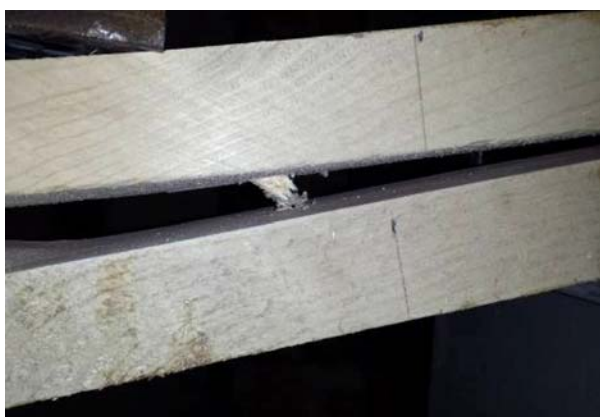
Fig. 17. Pull out of the BFRP spike

is maximum. After timber failure, the BFRP bars do not exhibit any damage, but partially separated from the epoxy resin in the holes (Fig. 17).

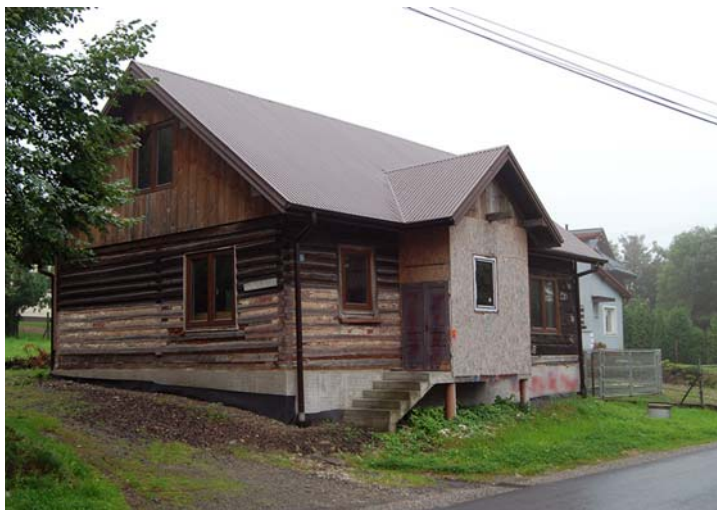
Fig. 1. A single-family house at 41 Ochojno, Świątniki Górne municipality – relocation of fragments of the building to replace damaged elements – Ł. Wesółowski, 2016

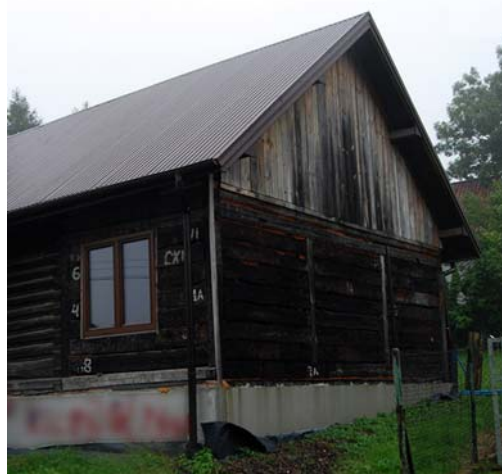
Ryc. 2. Dom jednorodzinny w Ochojnie 41, gm. Świątniki Górne – relokacja fragmentu budynku w miejsce zniszczonej części – zbliżenie – Ł. Wesółowski, 2016

Fig. 2. A single-family house at 41 Ochojno, Świątniki Górne municipality – relocation of fragments of the building to replace damaged elements – a close-up – Ł. Wesółowski, 2016

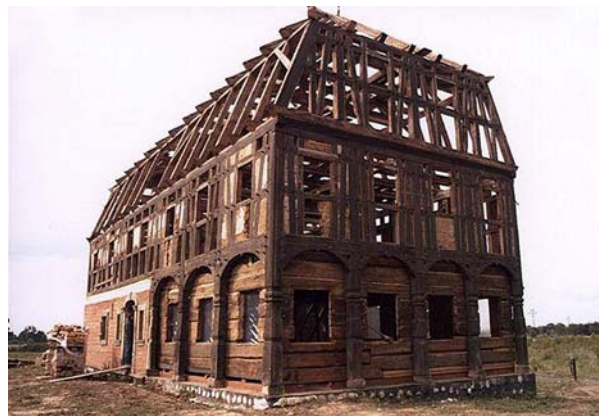
Ryc. 4. „Zagroda Kołodzieja” w Zgorzelcu – montaż konstrukcji w nowej lokalizacji – <http://www.zagrodakolodzieja.pl/file.php?id=386&w=&h=&>, dostęp 08.2016

Fig. 4. 'Wheelwright's Homestead' in Zgorzelec – assembly of the structure in the new location – <http://www.zagrodakolodzieja.pl/file.php?id=386&w=&h=&>, accessed in August 2016

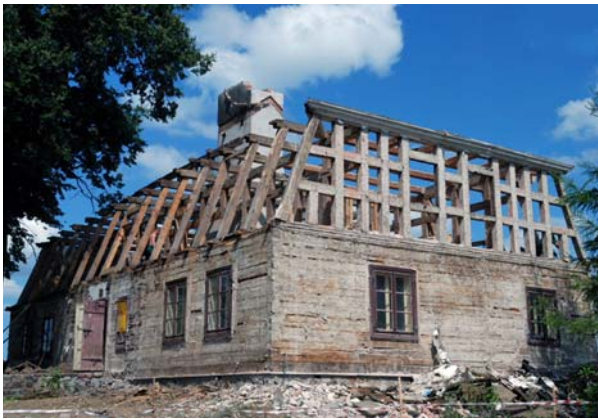
Ryc. 5. Dwór szlachecki w Uniszkach Zawadzkich – demontaż konstrukcji – <http://mwmskansen.pl/wp-content/uploads/2011/12/7.-dw%C3%B3r-w-Uniszkach-Zawadzkich-trakcie-prac-rozbi%C3%B3rkowych.jpg>, dostęp 08.2016

A much more common method involves disassembly and reassembly of a structure in a new location. This is because highly qualified teams and specialist equipment are not required. Although the process is more time-consuming, it allows invisible defects of building structures to be eliminated, which would be subjected to vibrations and transverse forces during transportation. Some technologies, such as timber or steel structures, are originally prefabricated as consisting of larger elements. The elements interact with each other in structural nodes, reducing force reaction on the surface of elements. Such structures can be partitioned and subsequently joined together again, which enables relocated elements to be matched in size to the transportation means available. In recent years, several buildings have been relocated in Poland. They have gained recognition in their new locations and been given a second-life. Abandoned and forgotten in their original locations, when rebuilt in new places their history has

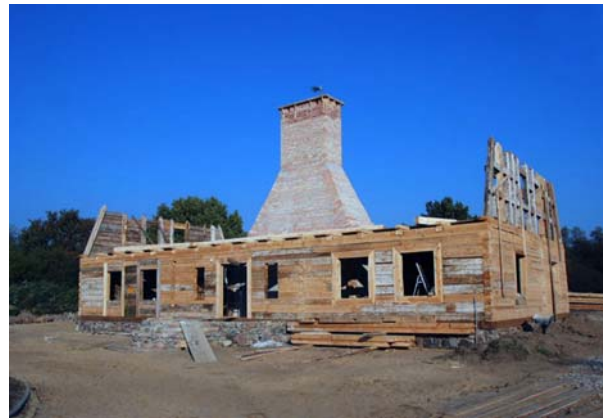
Ryc. 6. Odbudowa dworu szlacheckiego na terenie Muzeum Wsi Mazowieckiej w Sierpcu – <http://mwmskansen.pl/wp-content/uploads/2011/12/11.-Budowa-dworu-na-terenie-skansenu.jpg>, dostęp 08.2016

Fig. 6. Reconstruction of the manor house at the Museum of the Mazovian Countryside in Sierpc – <http://mwmskansen.pl/wp-content/uploads/2011/12/11.-Budowa-dworu-na-terenie-skansenu.jpg>, accessed in August 2016

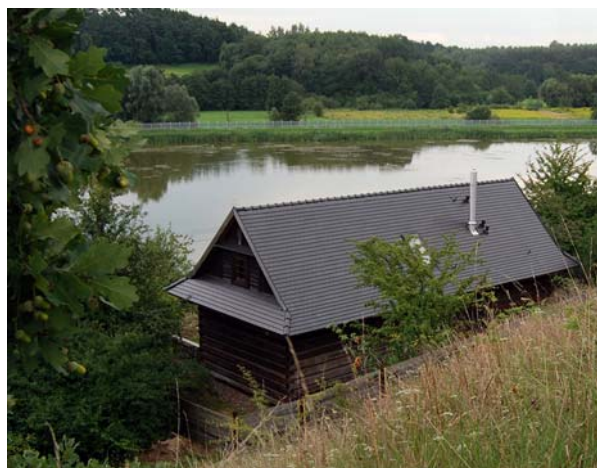
Ryc. 8. Dom jednorodzinny w podkrakowskich Balicach, widok od strony północno-wschodniej – Ł. Wesółowski, 2016

Fig. 8. A single-family house in Balice near Krakow – the north-east view – Ł. Wesółowski, 2016

An interesting example, integrating traditional and contemporary solutions, is a single-family house relocated from Skawa to Balice near Kraków. The house is more than a hundred years old and can be still used as originally designed. It is now in a new and more favourable location. The building is located on a steep slope. It is placed on a special steel frame mounted in a reinforced concrete spot footing. The levelled base performs a double role: it provides a stable and continuous bed for reclaimed wooden elements of the log walls, while at the same time, isolating them from the moisture in the ground. This additional elevation of the floor enables natural ventilation of the space beneath the building and releases radon emitted by processed building materials<sup>13</sup>. The logs have only been cleaned, the window and door openings have retained their original, small dimensions. The architectural form of the building has not been changed with wide roof eaves supported on brackets. The roof has been covered with contemporary ceramic brick with a wide assortment of ridge tiles and system sealing solutions. A contemporary colour was selected for the roof cover – it is dark graphite. The contemporary character of solutions is underscored by the glass balustrade railings installed on the outdoor deck, which is an extension of the frame upon which the house is set. Other contemporary elements include metal garden stairs finished with rough galvanized steel and fencing elements comprising gabions filled with local stone. A stainless steel chimney with modern balancing ropes, a roof window in the rear façade and numerous ventilation stacks attest to the fact that the building is equipped with contemporary installations. In the interior, the natural character of the house has been exposed with no facing covering building materials of walls and floors. Some decorative elements, the arrangement and furnishing of rooms and subtle details give the house a contemporary feel.

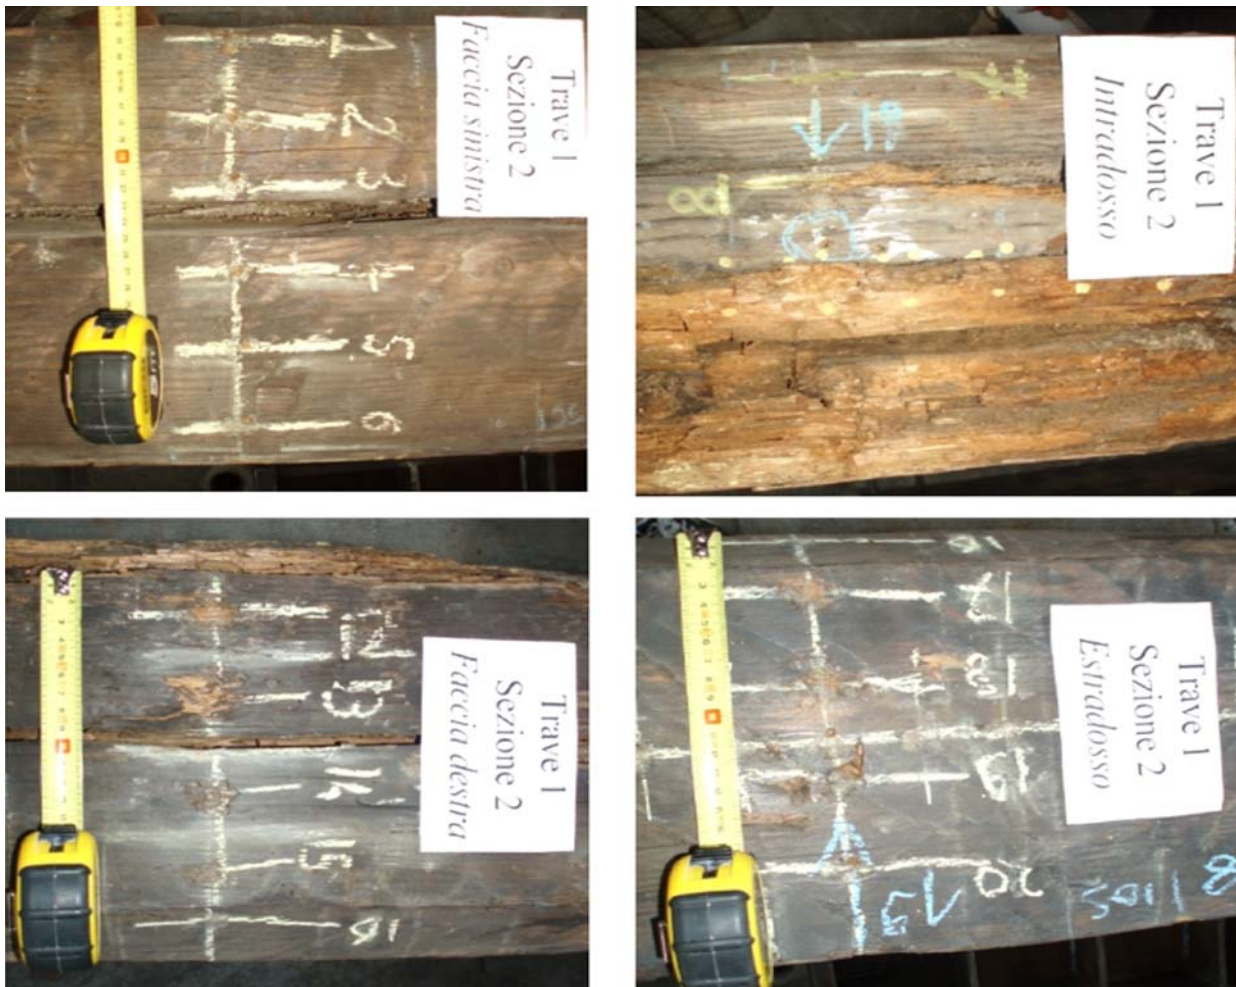
Fig. 4. Details of the beam 4 faces with tomography stations after data acquisition: left face and intrados (top left and right), right face and extrados (bottom left and right)

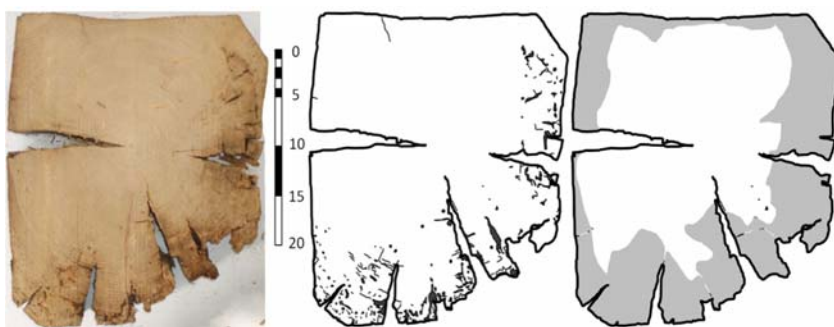
Fig. 7. Post-autopsy view of health situation of beam cross-section (legend in centimetres, left), distribution of insects attack on section surface (centre), decay distribution due to brown rot (right)

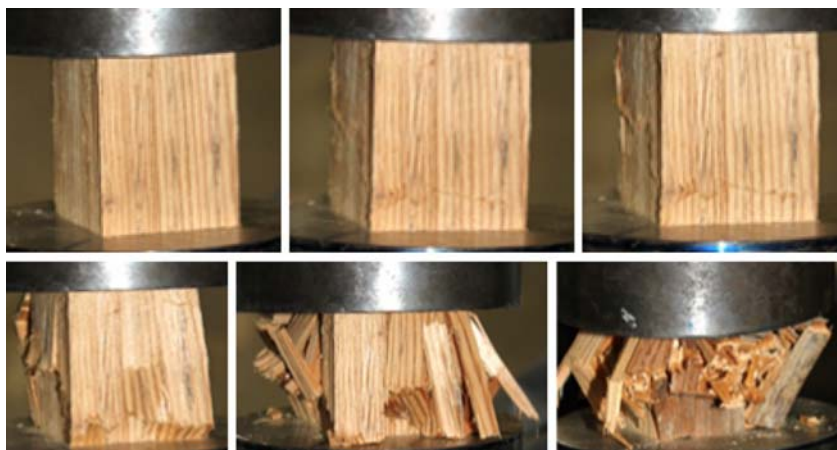
Fig. 10. Sequence of behaviour for specimen 12 under load

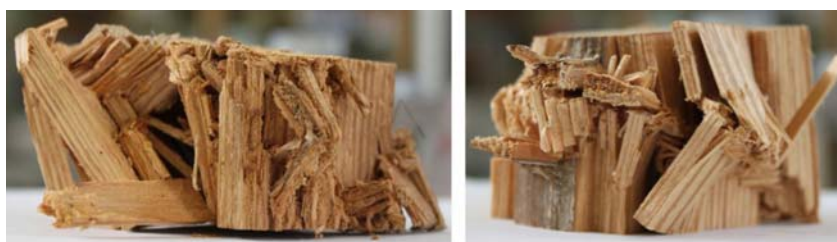
Fig. 11. Specimen 5 (left) and 12 (right) after testing

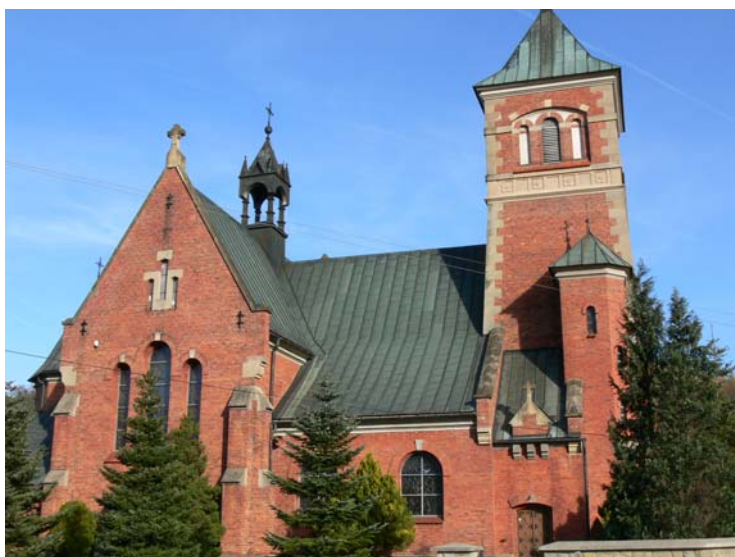
Ryc. 3. Bryła kościoła w widoku od strony zachodniej – zdjęcie autora  
Fig. 3. View of the church from the west – author's photo

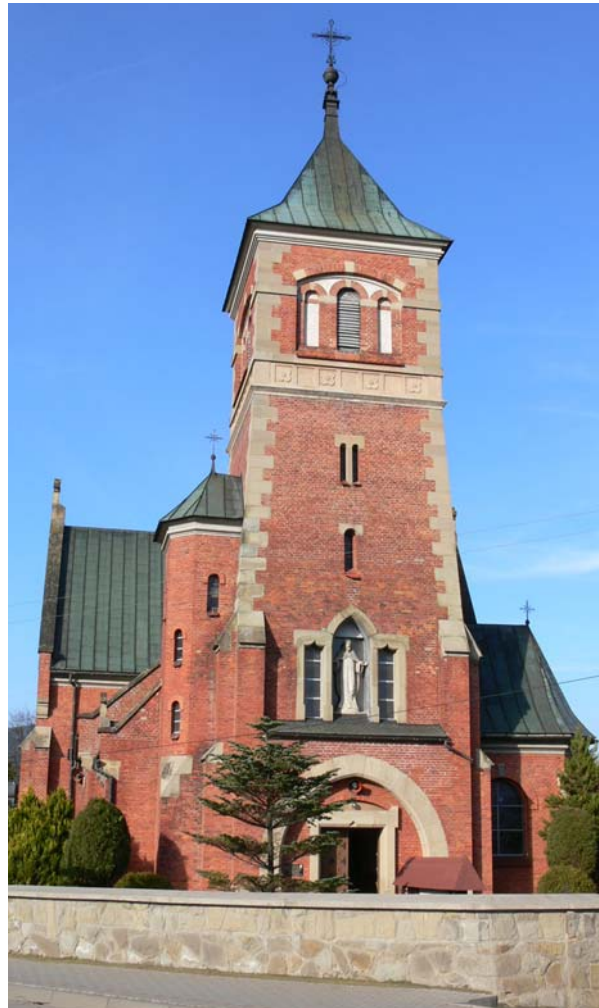
Ryc. 5. Widok od strony południowej – wieża kościoła – zdjęcie autora

Fig. 5. View from the south – church tower – author's photo

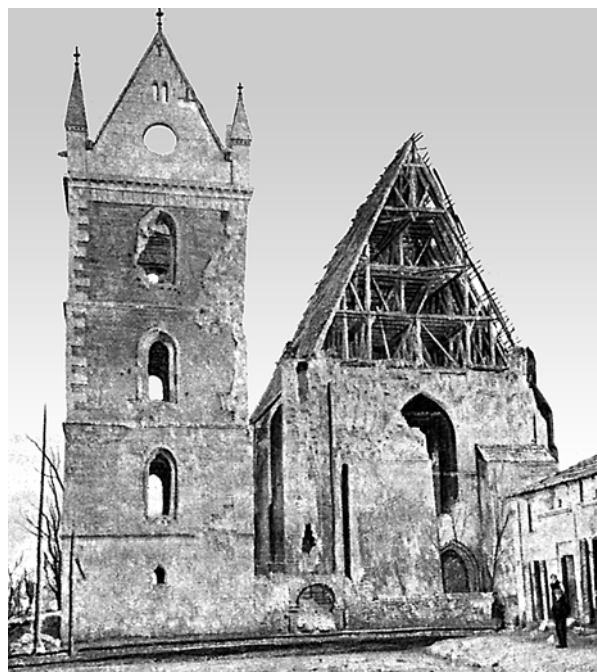
Ryc. 3. Wiślica, pow. buski, woj. świętokrzyskie. Fasada kolegiaty Narodzenia Najświętszej Marii Panny z 1350 r., po ostrzeleniu w 1915 r. przez artylerię austriacką. Reprodukcyjne zdjęcie z artykułu T. Szydłowskiego *O odbudowie kolegiaty...*

Fig. 3. Wiślica, Busko Dis., Świętokrzyskie Voivodeship. Facade of the collegiate church of the Nativity of the Theotokos from 1350, after shelling by Austrian artillery in 1915. Copies of photos from the article by T. Szydłowski *On rebuilding the collegiate church...*

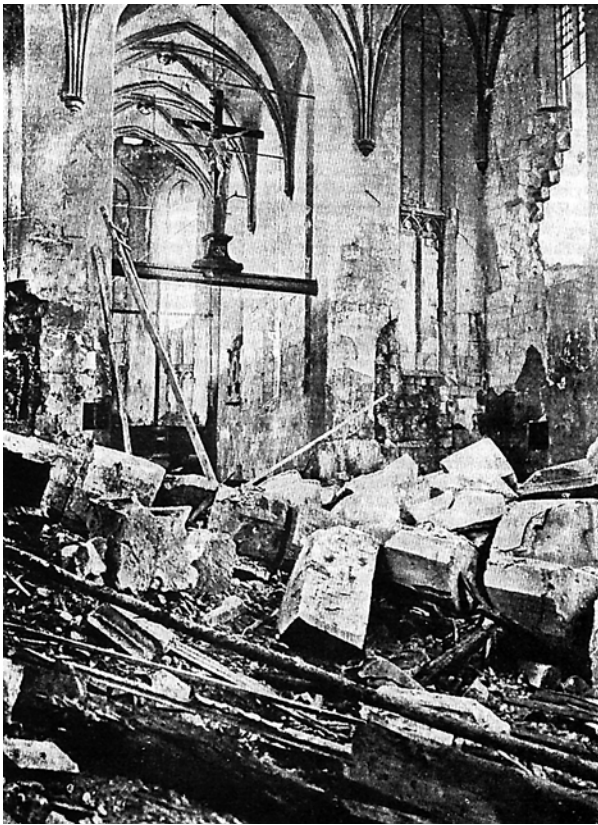
Ryc. 5. Wiślica. Zrujnowane wnętrze kolegiaty  
 Fig. 5. Wiślica. Ruined interior of the collegiate church

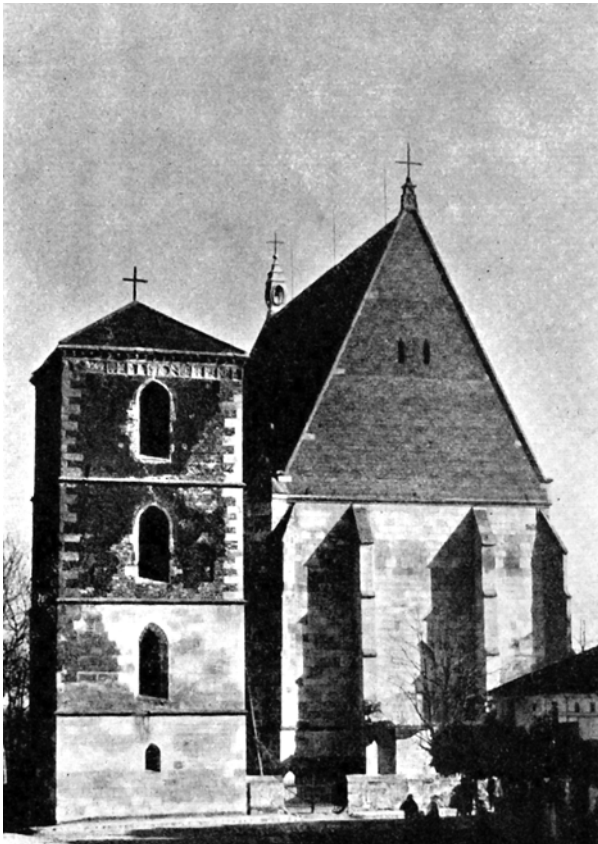
Ryc. 6. Wiślica. Widok fasady po odbudowie dokonanej w latach 1919–1926, według projektu prof. Adolfa Szyszko-Bohusza  
 Fig. 6. Wiślica. View of the facade after the reconstruction carried out in the years 1919–1926, according to the project by Prof. Adolf Szyszko-Bohusz

Przekonań tych, wynikających z jego głębokiej wiedzy o sztuce nowoczesnej, nie zachwiał zawód, jakiego doznał podczas nadzorowania odbudowy zniszczonej w latach 1914–1915 gotyckiej kolegiaty w Wiślicy pw. Narodzenia NMP, z drugiej połowy XIV w. Poważne jego zastrzeżenia wzbudziły wówczas zaprojektowane przez Adolfa Szyszko-Bohusza (1883–1948), jednego z najwybitniejszych polskich architektów i konserwatorów zabytków pierwszej połowy XX wieku, nowe detale wyposażenia wnętrza (m.in. stalle i chór muzyczny) oraz elementy zewnętrznego wystroju architektonicznego: „pękata i wybrzuszona” wieżyczka na sygnaturkę, a przede wszystkim niezrealizowana neobarokowa kruchta, które ocenił jako „fałszywe historycznie”. Było to dla autora *Ruin Polski* zapewne przykre przeżycie, bowiem z dłu-

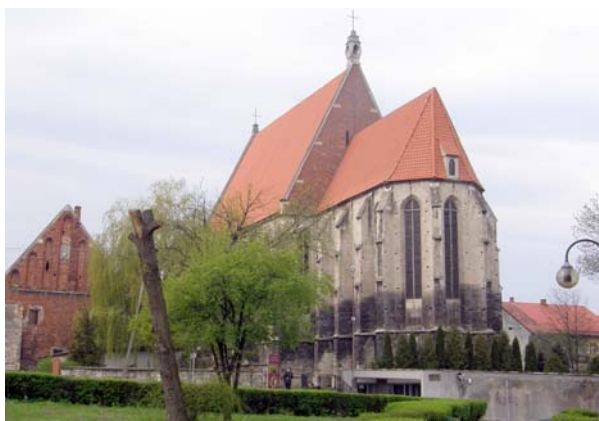
Ryc. 10. Wiślica. Bazylika kolegiacka z południowego wschodu. Widoczna sygnaturka na wschodnim szczycie nawy zaprojektowana przez A. Szyszko-Bohusza. Fot. autor

Fig. 10. Wiślica. Collegiate basilica from the south east. Little belfry visible on the east ridge of the nave designed by A. Szyszko-Bohusz. Photo: author

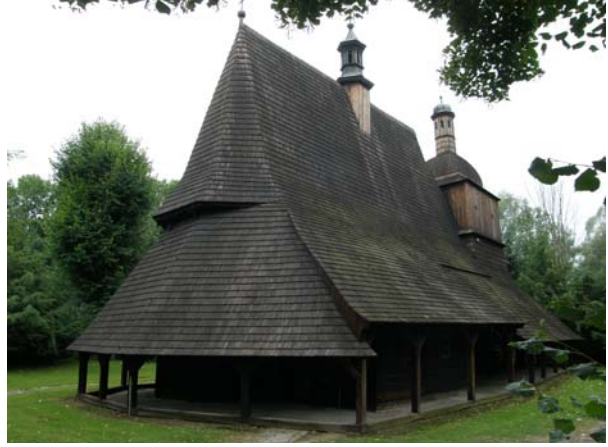
Ryc. 12. Sękowa. Kościół drewniany obecnie. Od 2003 r. na Liście Dziedzictwa Światowego UNESCO, umieszczony w ramach wpisu kościołów drewnianych Małopolski. Fot. autor

Fig. 12. Sękowa. Timber church nowadays. Since 2003 on the UNESCO World Heritage List, entered as one of the wooden churches of Lesser Poland. Photo: author

It was confirmed by his approach to the reconstruction of the wooden church in Sękowa, dedicated to St. Philip and Jacob, erected at the beginning of the 16<sup>th</sup> century, most likely during the years 1520–1522, also (like the collegiate church in Wiślica) badly damaged during World War I. When Sękowa was captured by the Austro-Hungarian troops, the Austrians organised stables in the church. They dismantled large fragments of larch walls, the surrounding arcades and roof covering, and the timber was utilised for strengthening their trenches and firewood. They also vandalised the church furnishings, and if the Operation Gorlice which started on 2.05.1915 had been delayed by a few days, the church would have ceased to exist.

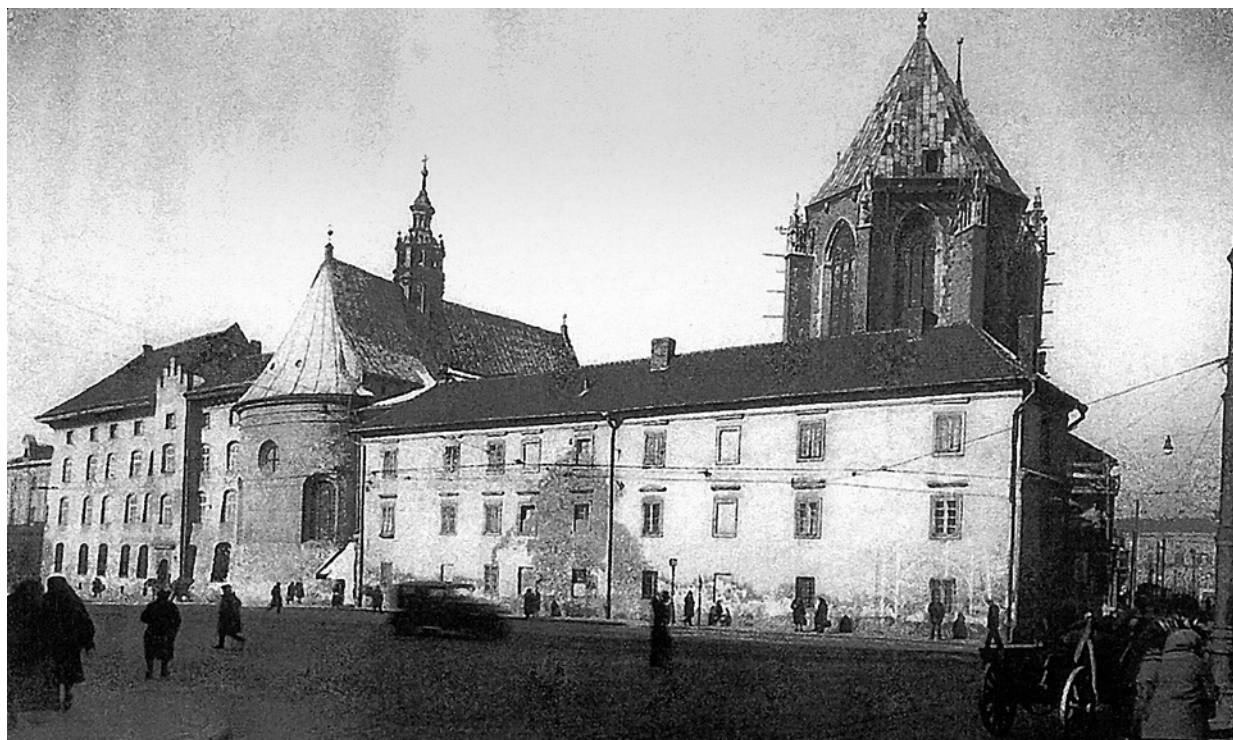
Ryc. 15. Kraków, Mały Rynek. Widok na budynek starej wikarówki z XVII/XVIII w. Stan przed rozbiórką w 1934 r. Fot. A.F. „Światowid” Reprod. ze zbiorów autora

Fig. 15. Krakow, Mały Rynek. View of the old vicarage building from the 17<sup>th</sup>/18<sup>th</sup> century. State before its demolition in 1934. Photo: A.F. “Światowid”. Copy from the author's collection

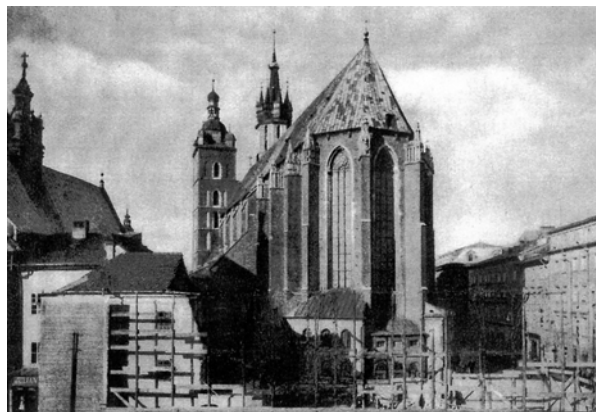
Ryc. 16. Mały Rynek. Widok na prezbiterium bazyliki Mariackiej po rozbiórce wikarówki z XVII/XVIII w. Stan z września 1934 r. Fot. St. Kolowca, pocztówka ze zbiorów autora

Fig. 16. Mały Rynek. View at the presbytery of the St. Mary's Basilica after the demolition of the vicarage from the 17<sup>th</sup>/18<sup>th</sup> century. State from September 1934. Photo: St. Kolowca, postcard from the author's collection

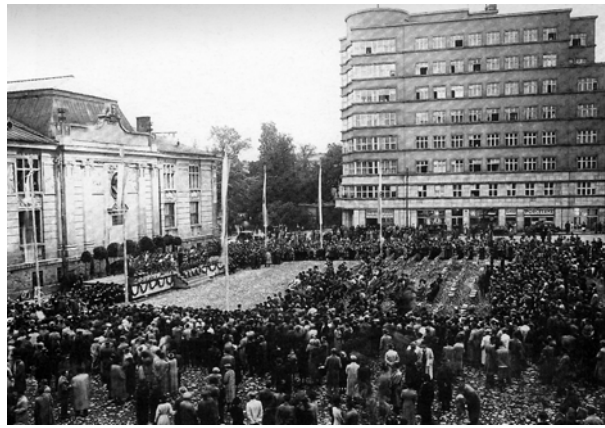
Ryc. 19. Kraków. Dom czynszowy Funduszu Emerytalnego Komunalnej Kasy Oszczędności Powiatu Krakowskiego przy pl. Szczepańskim 5 i ul. Reformackiej 1. Fot. A.F. „Światowid”. Reprod. Archiwum WKZ w Krakowie

Fig. 19. Krakow. Tenement house of the Retirement Fund of the Communal Savings Bank of the Krakow District at 5 Szczepański Square and 1 Reformacka St. Photo: A.F. "Światowid". Copy Archive of the VMC in Krakow

Although he had prepared basic conditions for shaping new building development in the historic surroundings, and despite his protests, in the years 1933–1934 a tenement house of the Retirement Fund of the Communal Savings Bank for the Krakow District was erected on the corner of Szczepański Square and Reformacka Street, according to the project by architects Fryderyk Tadanier and Stefan Strojek<sup>32</sup>.

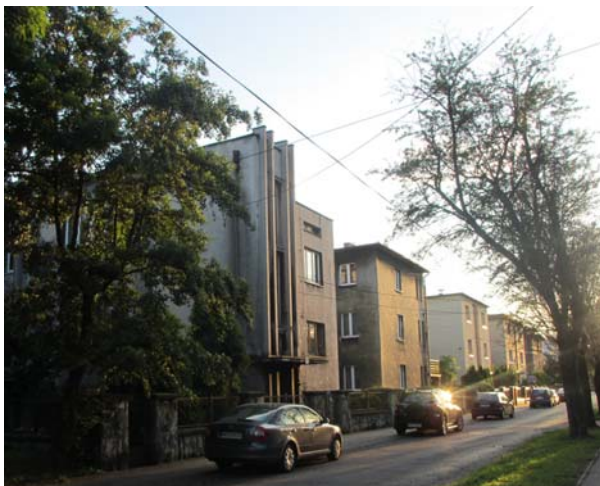
Ryc. 5. Kolonia urzędnicza Nowa Ligota, widok współczesny (ul. Huculska), fot. autorka, 08.2016

*Fig. 5. Office workers' colony Nowa Ligota, current view (Huculska St.), photo: author, 08.2016*

Katowice as the capital of the voivodeship and a centre of growing economic – administrative importance was bursting out of its previous limits. After the city annexed the neighbouring areas, there opened a possibility of further expanding Katowice, mainly along the north-south line. At that time a concentration of new administrative and housing building took place in the newly incorporated southern quarters of the city. Thanks to the decision concerning establishing Greater Katowice, the city area increased 5 times. Incorporation of new districts also changed its character: from a relatively homogeneous, urbanised city area into a mosaic of areas with varying forms of building development. Appropriate urban planning was necessary in order to properly develop such stretches of land. The first Polish plans were created in the years 1924, 1930, but they did not satisfy the growing needs of the city. It was only the plan of regulation and transformation, selected in 1935 as a result of a competition organised by the city authorities in cooperation with the Polish Urban Planners Association and the Architects Association, which provided a solution for the developing centre. The plan prepared by Władysław Czarnocki and Marian Spychalski predicted intensive urbanisation of the city area by building development of the inside plots increasing the height of buildings. The main building sites were to be the new districts: Ligota and Brynów. The plan also assumed reorganising the communications system layout<sup>15</sup>. The plan adequately resolved problems in the city. Among the more important realised assumptions of the plan was building the office workers' colony in Ligota (fig. 5).

W architekturze kolonii ligockiej, projektowanej według wzorców międzynarodowego funkcjonalizmu, choć zróżnicowanej, dominują budynki mieszkalne przeznaczone dla jednej lub kilku rodzin. Najczęściej dwukondygnacyjne, o rozczłonkowanej bryle, kryte dachem płaskim w dwóch poziomach. Zauważyć można dążenie do podkreślenia reprezentacyjnego, luksusowego charakteru willi. Osiągnięto to poprzez stosowanie tarasów, dużych balkonów, obszernych przeszkleń, także z wypełnieniami dekoracyjnymi (witraże), ryzalitów. Warto zauważyć, że elewacje zostały opracowane w sposób staranny, szczegółowy, z dbałością o dekoracyjny oryginalny detal, a wykonanie także było na wysokim poziomie. Stylistycznie większość architektury willi ligockich mieści się w nurcie modernistycznym. Do wybuchu II wojny światowej zabudowano 89 z wytyczonych 193 działek, należących, wbrew pierwotnemu założeniu nie do szeregowych urzędników, ale do ludzi majątnych, głównie przedstawicieli wolnych zawodów. Wpływ na ten fakt miała wysoka cena parceli. Za najciekawsze wille kolonii w Ligocie można uznać następujące budynki: willa dra Bolesława Mroczkowskiego (ul. Mazowiecka 1, proj. Lucjan Sikorski, 1937 rok, założona na planie wycinku koła), willa Antoniego Pająka (ul. Poleska 16, autor nieznan, budynek o wielopłaszczyznowej, plastycznej elewacji oraz dynamicznej kompozycji osiągniętej dzięki umiejętnemu operowaniu kontrastem, ryc. 6), willa dra Włodzimierza Kowala (ul. Mazowiecka 16, proj. Kazimierz Sołtykowski, 1937 rok, surowość formy, kubiczność układu), willa Ryszarda Holleka (ul. Poleska 26, proj. Henryk Firla, 1938 rok, rozczłonkowana elewacja z charakterystyczną przeszkloną pionową bryłą klatki schodowej, narożne okna), a także willa przy ul. Mazowieckiej 11 (proj. Glaesel, 1936–38, dominujący w elewacji ogrodowej zaokrąglony, przeszklony ryzalit, zwieńczony zadaszonym tarasem).

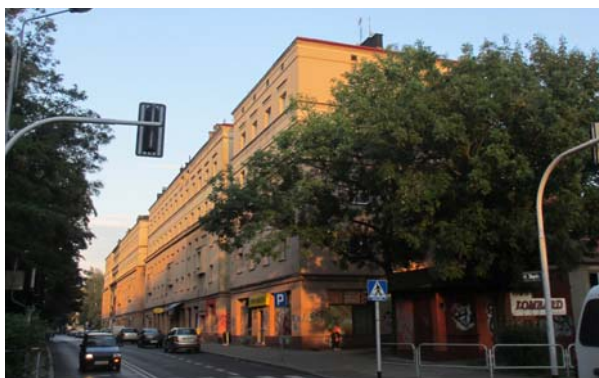
Ryc. 10. Zabudowa z lat pięćdziesiątych XX wieku. Widok w stronę ul. Słupskiej. Fot. autorka, 08.2016

Fig. 10. Buildings from the 1950s. View towards Słupska Street. Photo: author, 08.2016

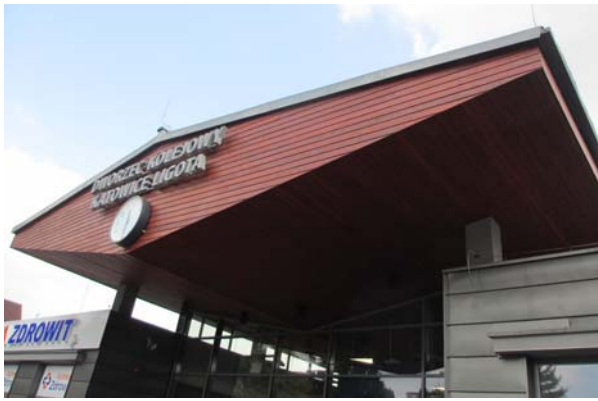
Ryc. 11. Dworzec kolejowy Katowice-Ligota po remoncie generalnym w 2016 roku. Fot. autorka, 08.2016

Fig. 11. Railway Station Katowice-Ligota after a complete refurbishment in 2016. Photo: author, 08.2016

spatial transformations in the housing estate have not altered. Some buildings have gradually been renovated (mainly simple thermos-modernisation), several buildings have undergone specialist, mostly quite successful adaptations. Among those there are: the railway station building (fig. 11), the *Ligota* House of Culture (fig. 12), the City Public Library no 7 (fig. 13), Central Clinical Hospital. New investments, besides single-family houses, were mostly commercial and service large-format buildings. Five of them have been built during the last few years, all of them along the stretch of Ligocka – Piotrowicka – Armii Krajowej Streets. They are similar cuboid blocks, 1–2 storeys high, covered with flat and gable roofs, a sign of consumption times. Only the housing estate built in recent years within the area between Ligocka and Ostrawska streets (so called Osiedle Książęce) keeps outside the pattern, consisting of several four-storey-high multi-family blocks and some office blocks of modern architecture not forcing itself upon the already existing surroundings (office block at 6 Armii Krajowej St., a passive office block at Ligocka Street in the Euro-Centre Science and Technology Park).

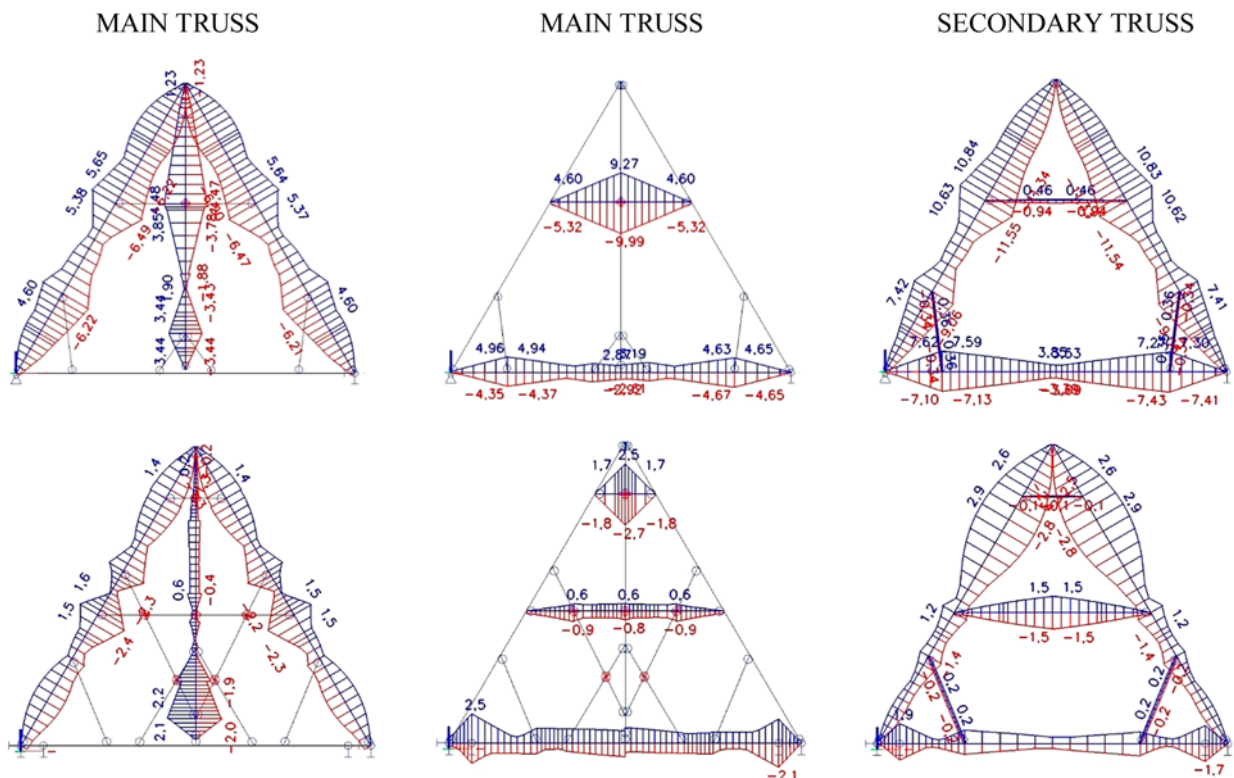
Fig. 5. Normal stresses (MPa) in the major truss members in a) Bela-Dulice, b) Okolicne
