# WIADOMOŚCI KONSERWATORSKIE

JOURNAL OF HERITAGE CONSERVATION

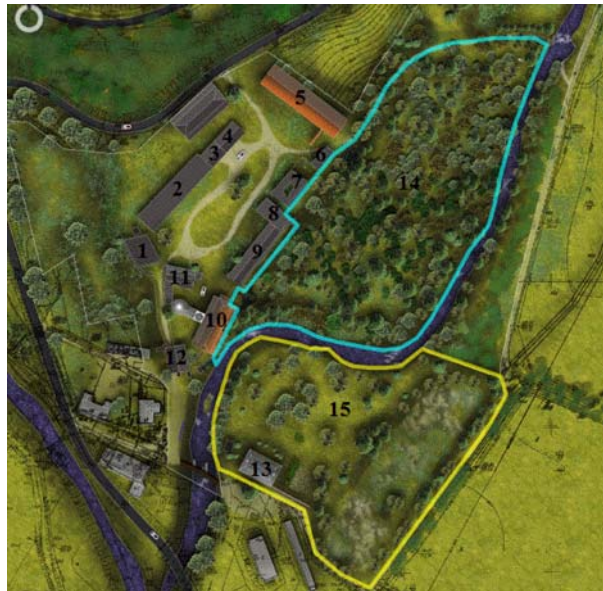
Fig. 7. Plan of the Manor House and park complex in Sarny: 1 – granary, 2 – cowshed, 3 – storage, 4 – residential building, 5 – shed, 6, 7 – carriage house, 8, 9 – cowshed, 10 – palace, 11 – residential building, 12 – gate house, 13 – summer palace, 14 – upper park, 15 – lower park (based on: Przybylak Ł., Plan of the Sarny Manor House and Park complex, Hortus Excelsior, 2014)

The Sarny estate – a local knight's seat – was first mentioned in 1400 [1]. The Manor House complex in Ścinawka Górna (fig. 5, 6, 7) is an example of residential architecture of the 16<sup>th</sup> and 17<sup>th</sup> centuries. At that time, it was the seat of the Reichenbach family. The estate's location near the main trading route from Nowa Ruda facilitated its development. The Manor House was built in 1590 by Fabian von Reichenbach and at the time was the second largest residence in the County of Kłodzko,

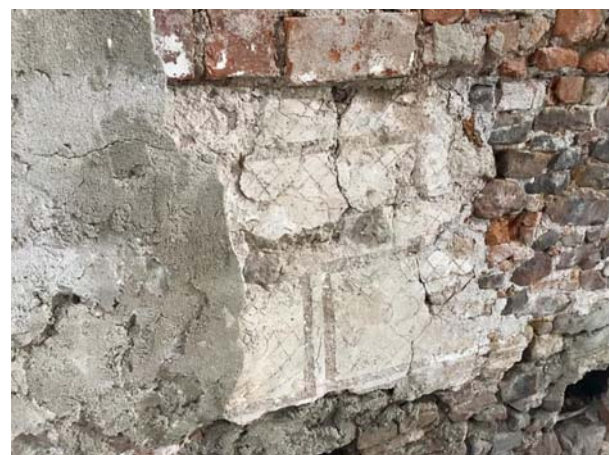
Ryc. 9. Sgraffito z XVIII wieku na wewnętrznej ścianie spichlerza (fot. Fundacja Odbudowy Dworu Sarny)

Fig. 9. The 18<sup>th</sup> century sgraffito on the internal wall of the granary (photo: Foundation for Restoration of the Sarny Manor House)

The granary building, which has survived to modern times, was constructed in the first half of the 18<sup>th</sup> century (fig. 9) as a commission of Antoni von Götzen. The original granary was built in the Baroque style, but was subsequently rebuilt in the Neogothic style in the second half of the 19<sup>th</sup> century. It is a three-storey building constructed of brick and stone, on a rhomboid floorplan. The double gables are a characteristic feature of the building, which was covered with a butterfly roof, made probably from local slate tiles. Despite its name, the granary was not used originally for storage. The large number of windows placed in its three walls suggest that the building was used for another purpose [2].

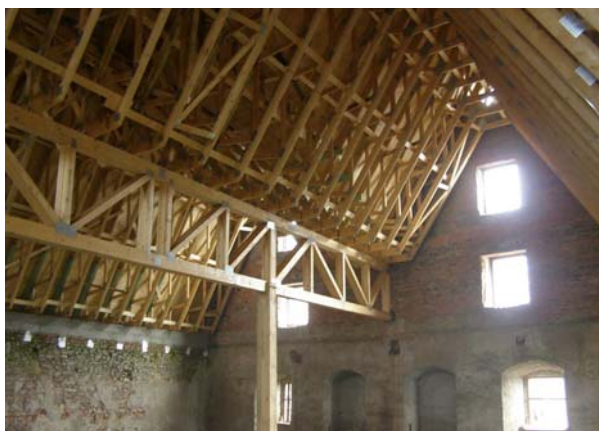
Ryc. 11. Wieżba dachowa po montażu w ramach adaptacji spichlerza w grudniu 2014 r. (fot. Fundacja Odbudowy Dworu Sarny)

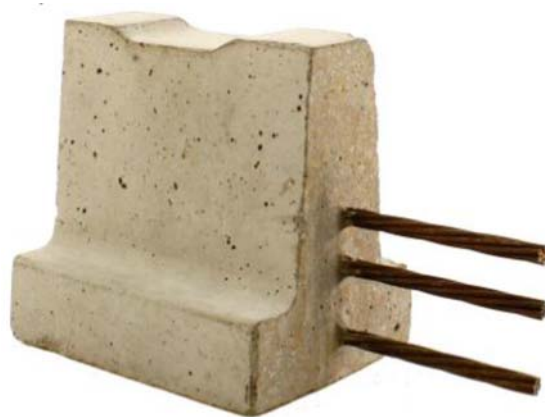
Belka sprężona

W gamie belek wyróżnia się trzy główne rodziny: RS 110 (wysokość 11 cm), RS 130 (wysokość 13 cm) i RSE (do montażu bezpodporowego). Produkowane są w rozpiętościach od 1 do 10 m, co 10 cm. Górna powierzchnia belek ma dyblowany kształt, co zapewnia jej dobrą przyczepność do betonu wylewanego na budowie. Dodatkowo dla zapewnienia dostatecznego zakotwienia zbrojenia sprężającego w żelbetonowych wieńcach stropowych, końce splotów wypuszczone są z powierzchni czołowych belek na długość min. 8 cm. Odpowiednio zaprojektowany strop jest w stanie przenieść obciążenia od słupków więźby dachowej lub ciężkich ścian działowych.

Dzięki zastosowaniu belek sprężonych możliwe jest uzyskanie większej rozpiętości stropów (do 8,5 m w systemie Rectolight i do 10 m w Rectobeton). W systemach Rector wykorzystuje się prefabrykowane, strunobetonowe belki RS obejmujące szereg odmian. Wykonane są z betonu i stali sprężającej o najwyższych parametrach wytrzymałościowych (beton C 50/60, stal klasy 2060 MPa).

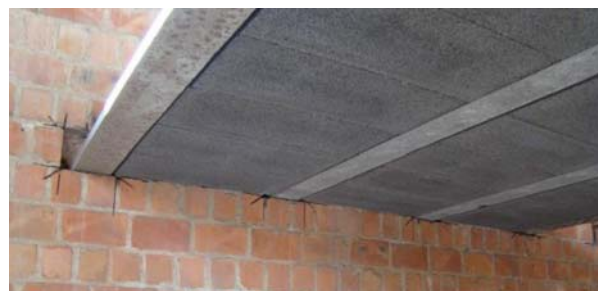
Oparcie na istniejącym murze

Strunobetonowe belki stropowe wpuszczają się w gniazda wykute w istniejących murach w rozstawach co 59 cm, na głębokość min. 7 cm. Belki opierają się na podporach montażowych lub wypoziomowanych wcześniej podlewkach betonowych. Jeżeli nie ma możliwości wykonania wieńca w istniejącej ścianie, stosuje się wieńiec obniżony oparty na belkach. Pierwszy rząd pustaków betonowych lub wypełnień Rectolight maksymalnie obniża się, tak aby uzyskać miejsce do przeprowadzenia wieńca z dwóch lub czterech prętów, a następnie kotwi się go w prostopadłych ścianach. W zależności od projektu możliwe jest obniżenie wieńca przy ścianach, na których opiera się strop, lub po obwodzie całego pomieszczenia.

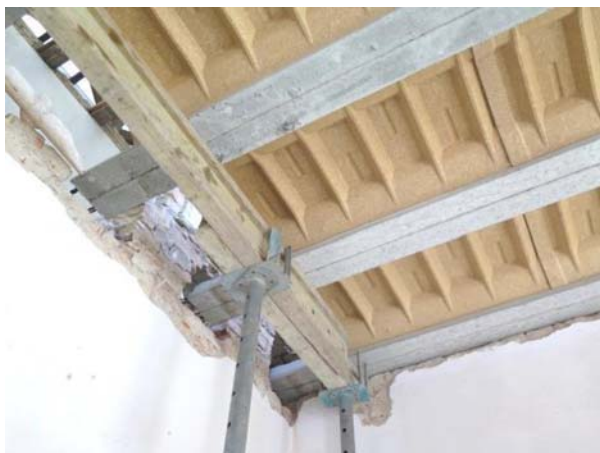
Podparcie belek na czas montażu

Brak żeber rozdzielczych, szalunków oraz ograniczona liczba podpór montażowych powodują, że strop montuje się niezwykle łatwo i bardzo szybko. Przy zastosowaniu wypełnienia Rectolight czas montażu wynosi zaledwie 0,65 roboczogodziny/m<sup>2</sup>.

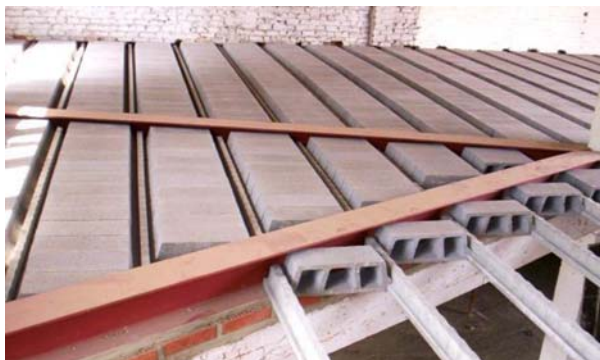
Połączenie systemu z belkami stalowymi

System stropowy jest na tyle elastyczny, że można opierać się belkami strunobetonowymi na podciągach stalowych. Elementy stalowe mogą być również zaprojektowane i wykonane w taki sposób, aby w całości lub częściowo ukryły się w grubości stropu.

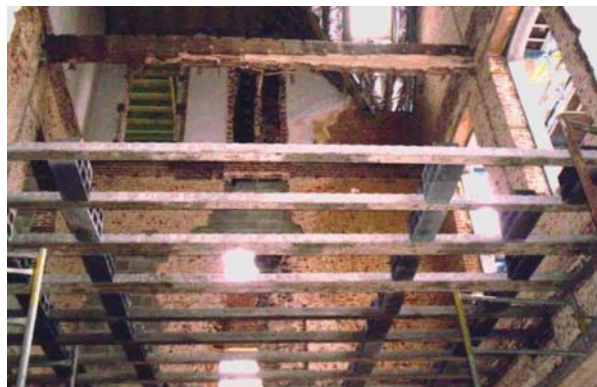
Montaż bezpodporowy

Zastosowanie specjalnej gamy belek RSE pozwala na wykonanie stropów bez podpór montażowych, co jest ogromną zaletą, szczególnie gdy niższe kondygnacje są stale użytkowane lub gdy wykonuje się nowy strop nad starym.

W przypadku bardzo wysokich pomieszczeń (np. obiekty sakralne) koszt rusztowań i stempli można ograniczyć, stosując system montażu bezpodporowego. Dzięki temu mamy możliwość wykonania stropu bez użycia podpór do rozpiętości 5,0 m (Rectobeton) lub 5,8 m (Rectolight).

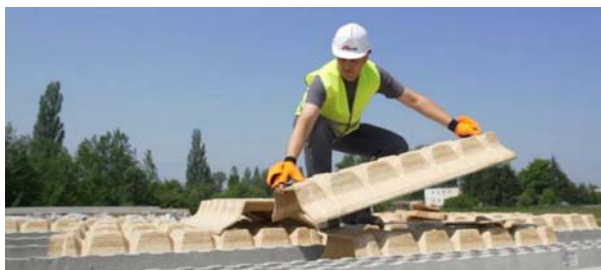
Panel Rectolight jest szalunkiem traconym, produktem drewnopochodnym, wykonanym ze sprasowanych wiórów drzewnych. Struktura panela podobna jest do płyty OSB. Dzięki temu element ten jest niezwykle lekki, a zarazem kilkakrotnie bardziej wytrzymały od pustaków betonowych. Badania wykazały, że panel jest w stanie wytrzymać obciążenie punktowe  $5 \times 5$  cm o wielkości przekraczającej 600 kg. Dodatkowo element długości 120 cm w zależności od wysokości waży zaledwie od 5,2 do 6,4 kg. Dzięki temu jedna osoba jest w stanie jednorazowo unieść 4 szt. odpowiadające ok.  $3 \text{ m}^2$  stropu.

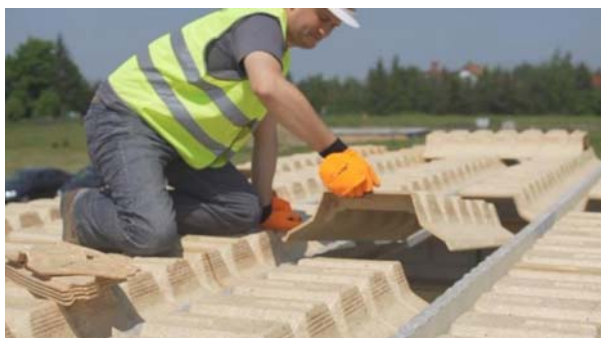
Układanie paneli Rectolight

Rectolight układa się bardzo szybko, ponieważ wyposażone są w pióro i wpust, dając możliwość regulacji rozstawu. Specjalne wypusty w górnej części panela unoszą zgrzewaną siatkę stalową eliminując potrzebę układania dystansów.

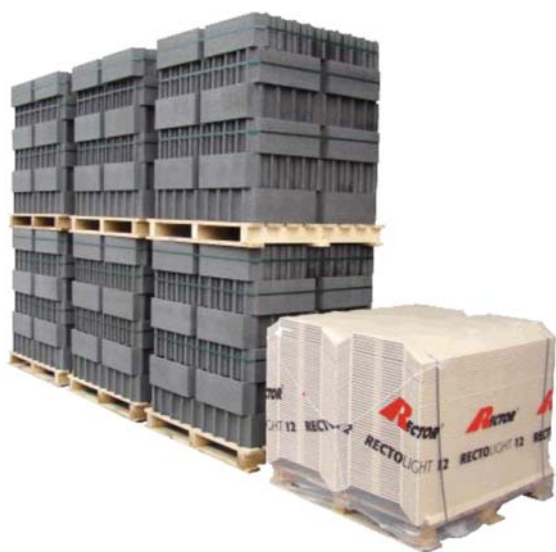
1 paleta Rectolight = 6 palet Rectobeton

Dzięki niewielkiej masie oraz powtarzalnej formie na jednej palecie można zmieścić wypełnienie odpowiadające nawet  $90 \text{ m}^2$  powierzchni stropu. Porównując zapotrzebowanie ilościowe pustaków betonowych z panelem Rectolight stwierdzamy, że na taką samą powierzchnię stropu potrzeba np. 8,83 kg paneli lub 127,95 kg pustaków betonowych. Pracownicy montujący strop z pustakami mają do przeniesienia elementy 14 razy cięższe.

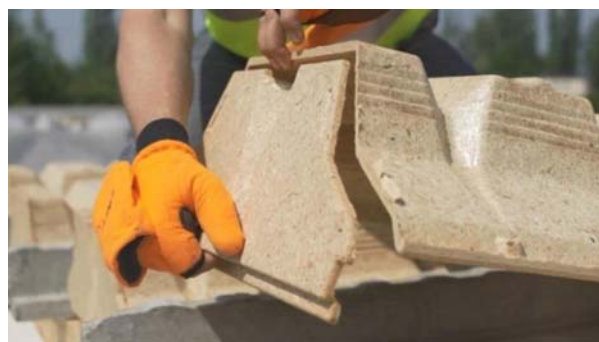
Montaż dekli

Uzupełnieniem systemu są dekle, które montuje się przy ścianie nośnej w celu uszczelnienia prefabrykatów przed ułożeniem mieszanki betonowej. Wysokość dekli jest tożsama z wysokością panelu i wynosi odpowiednio 12, 16 lub 20 cm.

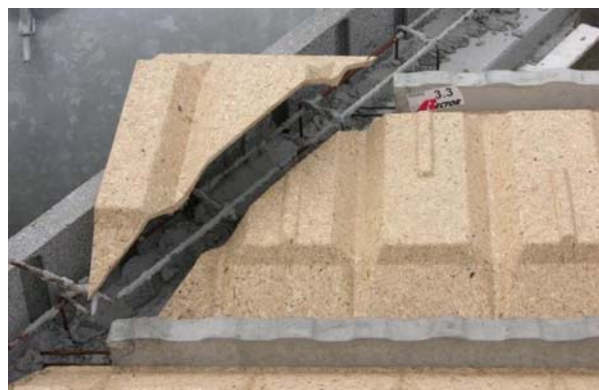
Łatwość docinania

Struktura materiału, z którego wykonany jest panel, pozwala na łatwą obróbkę. Docinanie, wycinanie otworów pod przepusty może odbywać się ręcznie za pomocą podstawowych narzędzi. Elastyczność systemu ułatwia pracę w budynkach istniejących, nieregularnych, wymagających zastosowania nietypowych detali.

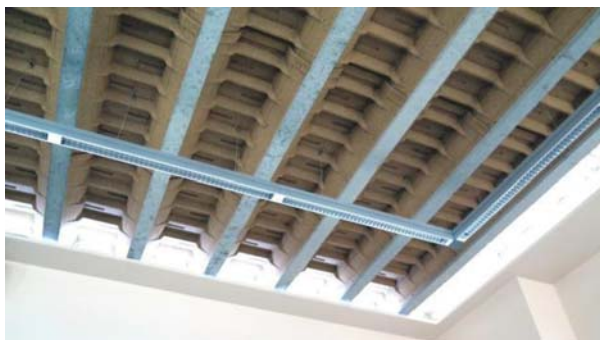
Rectolight bez sufitów podwieszanych

Coraz częściej zdarza się jednak, że architekci projektując wnętrza (zarówno w budynkach nowych, jak i przebudowywanych) rezygnują z sufitów podwieszanych, odsłaniając przewody instalacyjne oraz strukturę stropu. Oryginalna forma paneli Rectolight oraz struktura zbliżona do płyty OSB sprawia, że mogą stać się elementem wystroju wnętrza. Panel jest odpowiednio impregnowany, a system stropowy posiada parametr ognioodporności do REI 60. Wyższy parametr można uzyskać stosując odpowiedni system sufitów podwieszanych.
