# WIADOMOŚCI KONSERWATORSKIE

JOURNAL OF HERITAGE CONSERVATION

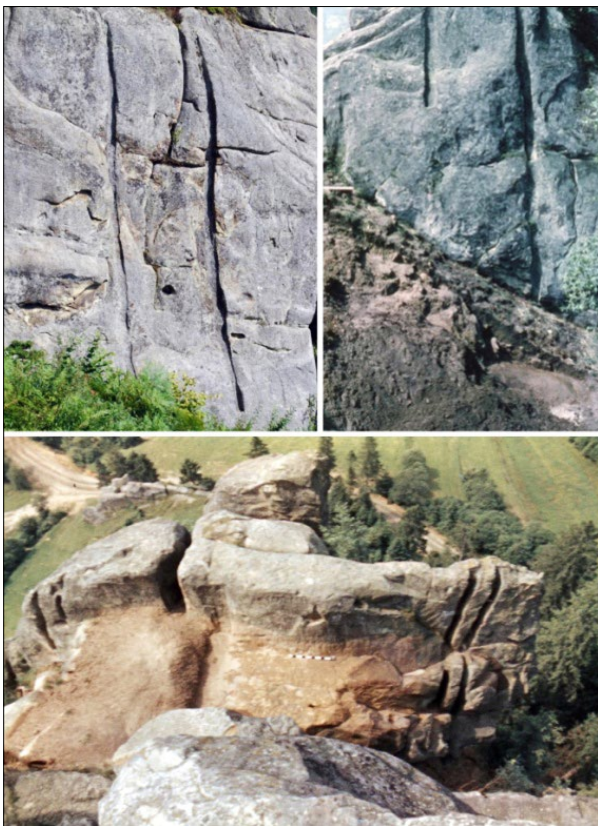
Fig. 3. Fragments of the rock group "Stone" with traces of fastening wooden structures, 1996; photo by M. Rozhko.  
 Ryc. 3. Fragmenty skalnej grupy „Skala” ze śladami kotwienia drewnianych obiektów, 1996; fot. M. Rożko.

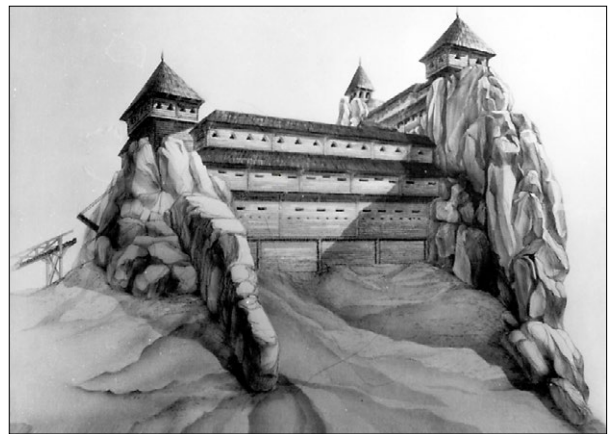
Fig. 6. Perspective of the Tustan rock fortress from the northeast, 1996; by M. Rozhko.

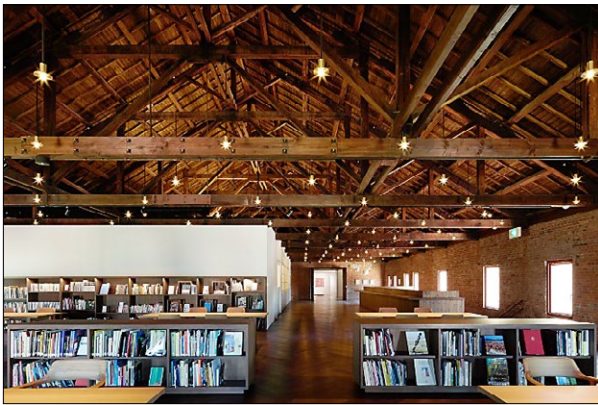
Fig. 1. Public library in a former brewery in Hirosaki, Japan, 2020; photo by D. Ano [[https://www.archdaily.com/944783/hirosaki-museum-of-contemporary-art-atelier-tsuyoshi-tane-architects?ad\\_source=search&ad\\_medium=search\\_result\\_all](https://www.archdaily.com/944783/hirosaki-museum-of-contemporary-art-atelier-tsuyoshi-tane-architects?ad_source=search&ad_medium=search_result_all)].

The library is housed on the top two floors of the renovated facility and features ultramodern equipment with enormous stacks of books in the center, digital resources and extensive reading and study materials. The library holds 125,000 volumes in the form of an inverted two-story book ziggurat, with stacks accessible by stairs and walkways.

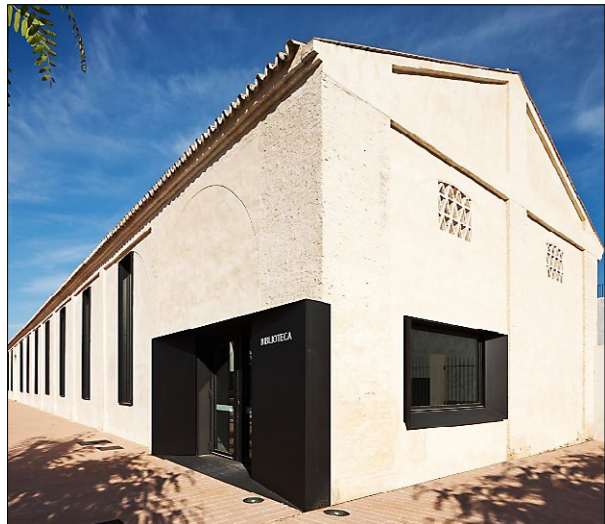
Fig. 2. Library in a former warehouse in Bogotá, Colombia, 2010; photo by F. Alda [<https://www.archdaily.com/140377/public-library-and-music-school-donaire-arquitectos>].

Inside, a gallery was arranged without disturbing the original structure of the building, in order to preserve and incorporate the original fittings into the overall structure. The renovated warehouse also sports a music school.

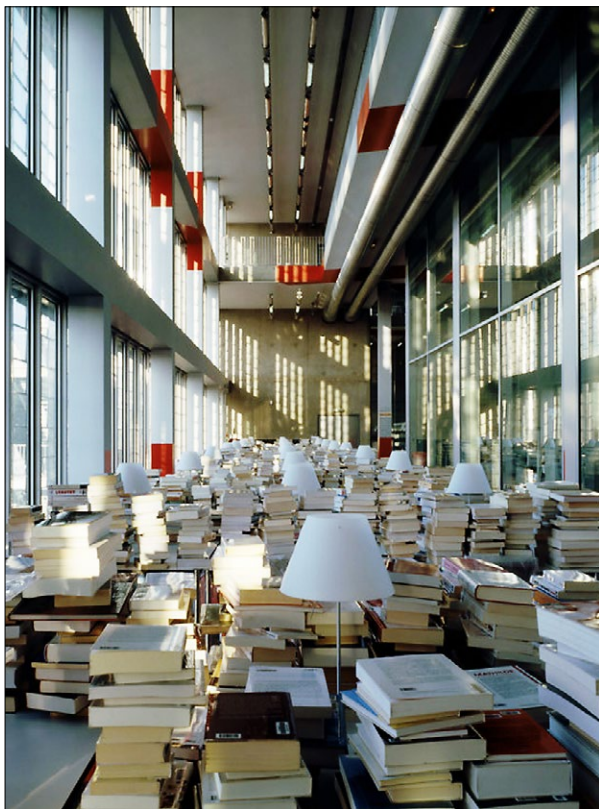
Fig. 4. Library in former Segmüller warehouses, Strasbourg; photo by D. Boudet [<https://www.architonic.com/en/project/jean-marc-ibos-myrtovitar-the-andre-malraux-library/5101723>].

Typical multi-story frame buildings are also used. For example, in Strasbourg, Segmüller's warehouses, located in the port area, have been converted into a modern public library. The warehouse was preserved as a vertical landmark in the landscape, marking the entrance to the port area from the side of the old town. The project retained the magnificent concrete structures. The extension is a vertical and horizontal ex-

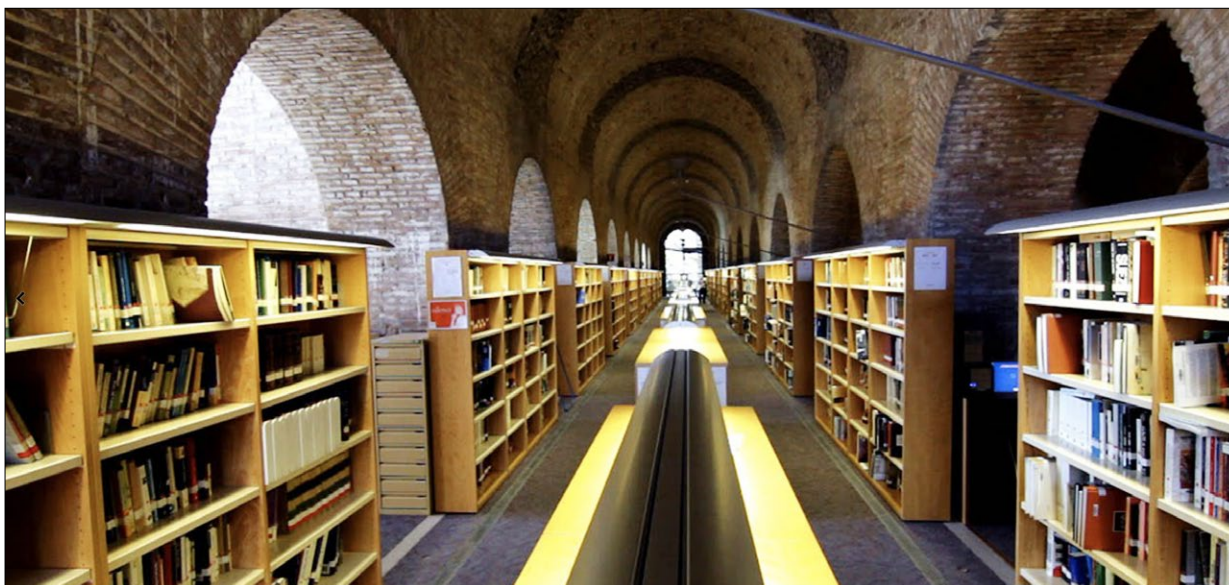
Fig. 6. Library in a former water reservoir in Barcelona; photo by S. Garcia [[https://architime.ru/specarch/josep\\_fontsere/universitat\\_pompeu\\_fabra\\_library.htm#1.jpg](https://architime.ru/specarch/josep_fontsere/universitat_pompeu_fabra_library.htm#1.jpg)].

Storage structures are also used in adaptive reuse projects. One example of such a structure is the brick water reservoir in Barcelona, built with the participation of Gaudi in 1874 and redesigned as a library a few years ago. The facility is located in Ciutadella Park; a building with high arches, on the roof of which there was a reservoir with a capacity of 15,000 m<sup>3</sup>, which was used to store water for irrigating the park. At present, this building houses the library of the University named after Pompeu Fabra. Brick pylons 1-m-thick and 14 m high support the arches with a span of 4 m. The walls have massive openings to save building materials. As a result, the image of the building resembles an ancient Roman reservoir. Subsequently, it was the large openings in the walls, thanks to which a large amount of

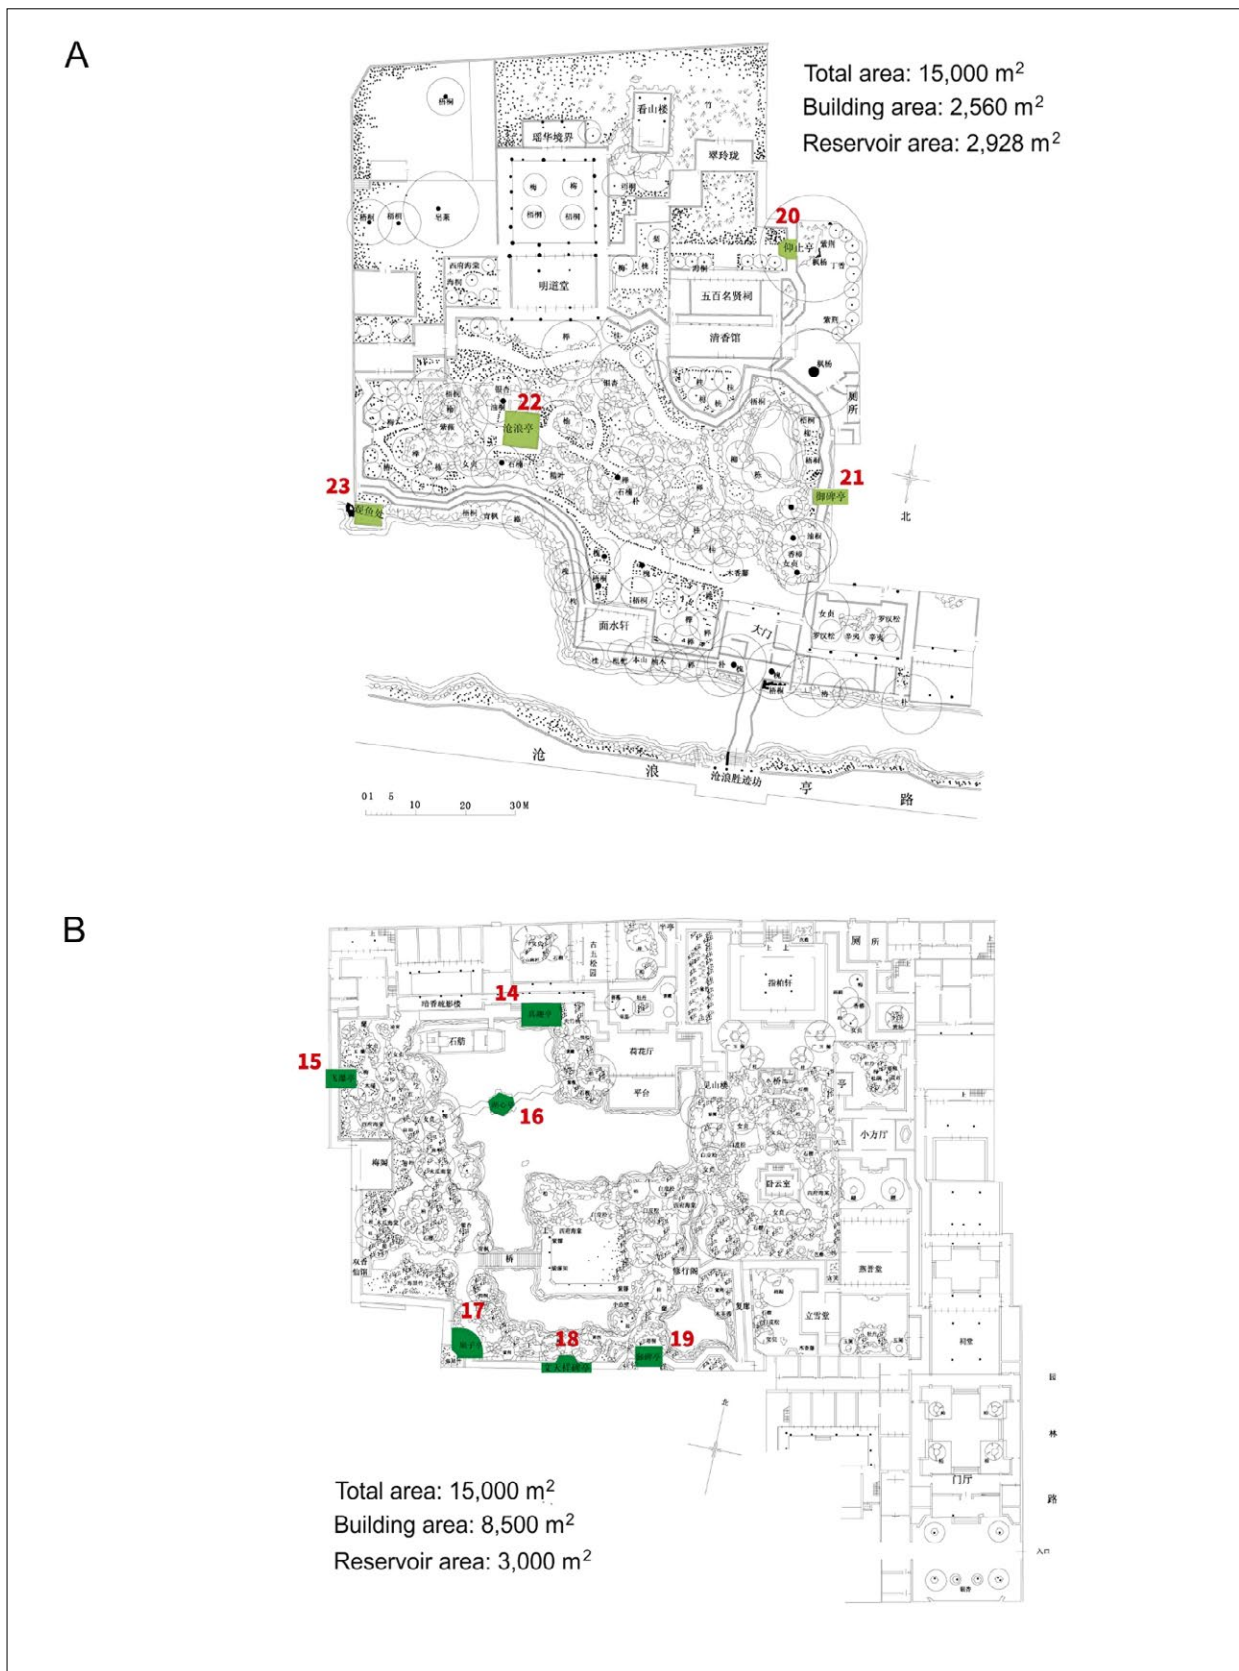
Fig. 8. Examples of the most famous Suzhou private gardens: A—plan of the Cang Lang Ting Garden, B—plan of the Shi Zi Lin Garden.  
 Ryc. 8. Przykłady najstynniejszych prywatnych ogrodów w Suzhou: A – plan ogrodu Cang Lang Ting, B – plan ogrodu Shi Zi Lin.

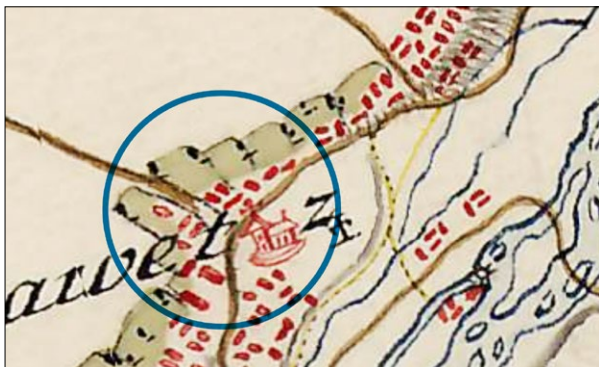
Fig. 2. Czarny Dunajec on the First Military Survey from the years 1779–1783 (Galicia and Lodomeria), the blue circle marks the center of the settlement with the forked marketplace [www.mapire.eu].  
Ryc. 2. Czarny Dunajec na Pierwszym Zdjęciu Wojskowym z lat 1779–1783 (Galicja i Lodomeria), niebieskim okręgiem oznaczono centrum osady z placem widlicowym [www.mapire.eu].

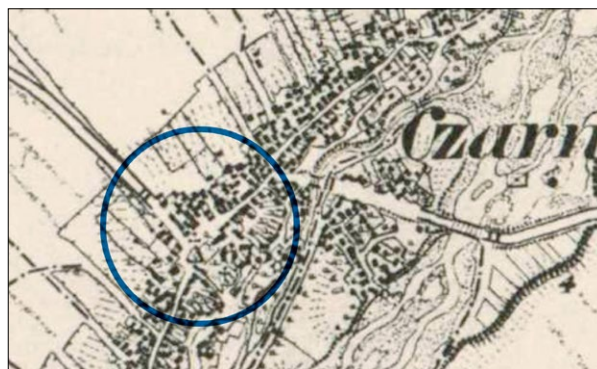
Fig. 4. Czarny Dunajec on the Third Military Survey from the years 1868–1887 (Galicia and Bukovina), the blue circle marks the center of the town with the rectangular market square in the middle [www.mapire.eu].  
Ryc. 4. Czarny Dunajec na Trzecim Zdjęciu Wojskowym z lat 1868–1887 (Galicja i Bukowina), niebieskim okręgiem oznaczono centrum miasteczka z prostokątnym rynkiem pośrodku; [www.mapire.eu].

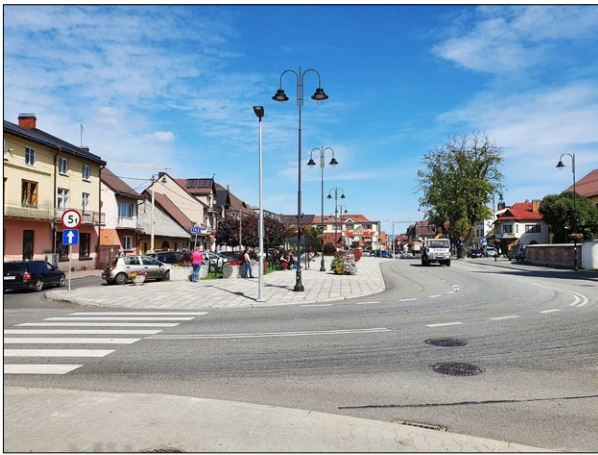
Fig. 10. View of the marketplace from the west, 2020; photo by the authors.

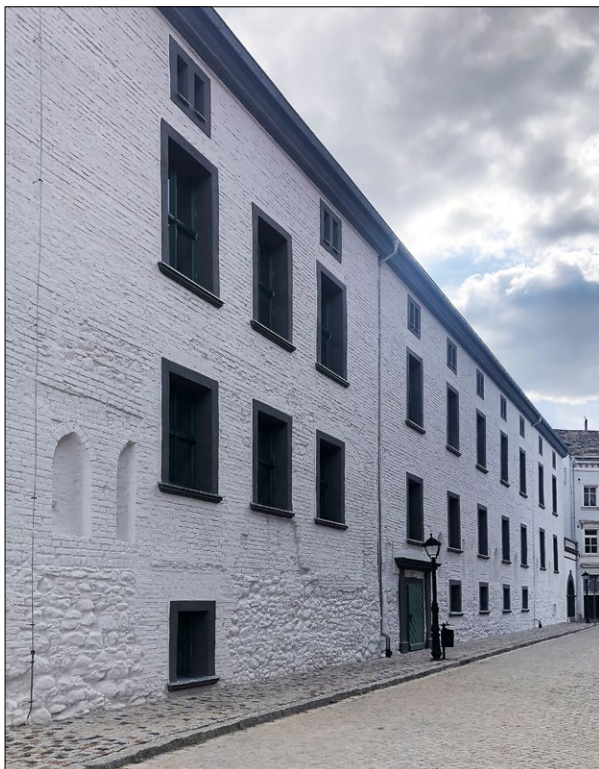
Ryc. 1. Szprotawa, dawny klasztor Magdalenek, widok od północnego wschodu, stan po pracach; fot. autor.

*Fig. 1. Szprotawa, the former Magdalene sisters abbey, view from the north-east, condition after the renovation works; photo by the author.*

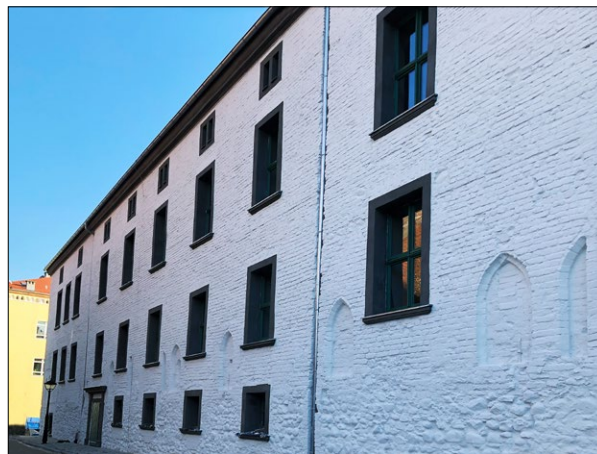
Ryc. 2. Dawny klasztor Magdalenek, widok od północnego zachodu, stan po pracach; fot. autor.

*Fig. 2. The former Magdalene sisters abbey, view from the north-west, condition after the renovation works; photo by the author.*

The northern front facade has a ten-axis structure, with an entrance on the ground floor located in the fourth axis (counting from the east). Window openings, which are rectangular on the upper floors, and square on the ground floor, are arranged regularly on a smooth wall without visible divisions. The middle bay was arranged in five axes. The western bay was built with windows in two axes, with the eastern one having windows in three. All the windows were framed and placed on windowsills. Ogival recesses are exposed in the strip between the ground floor and the first floor. The top of the wall is made of a strip of small square windows, which illuminate the loft, with a prominent cornice with a classic profile placed above them. The two-axis and two-story eastern facade has windows of different sizes: on the ground floor they are small in a sectional outline, and on the first and second floors they are large and rectangular. The southern opening of the first floor was replaced with a false window. The facade is crowned with a triangular gable, which is based on a crowning cornice. On the main axis, there are two narrow windows that illuminate the attic. In the strip between the ground floor and the first floor, relics of medieval decorations are visible—outlines of recesses and vaults. The western wall has a much more modest décor, with a door opening on the ground floor, and relics of Gothic décor displayed above in the form of engravings. The gable has a similar composition to the one from the east, but with one difference: there is a recess in the place of the northern window.

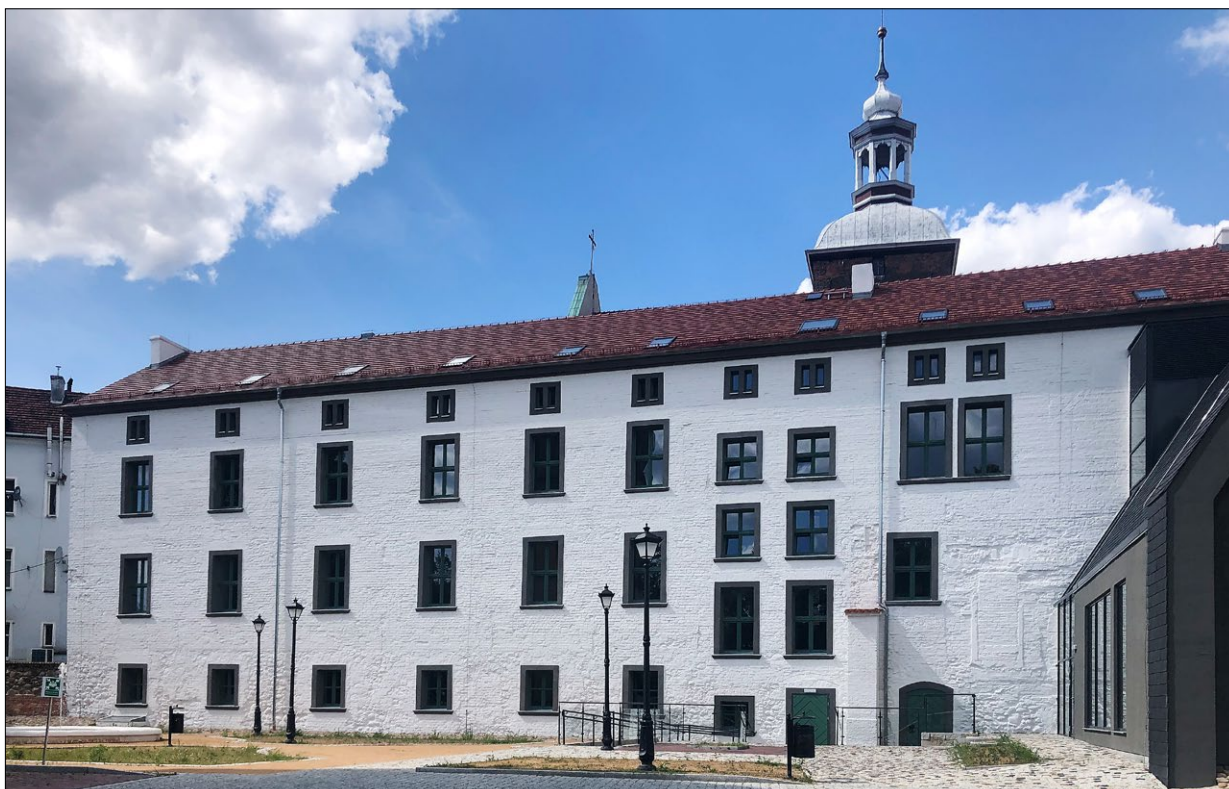
Ryc. 3. Widok od południa, stan po pracach; fot. autor.

Fig. 3. View from the south, condition after the renovation works; photo by the author.

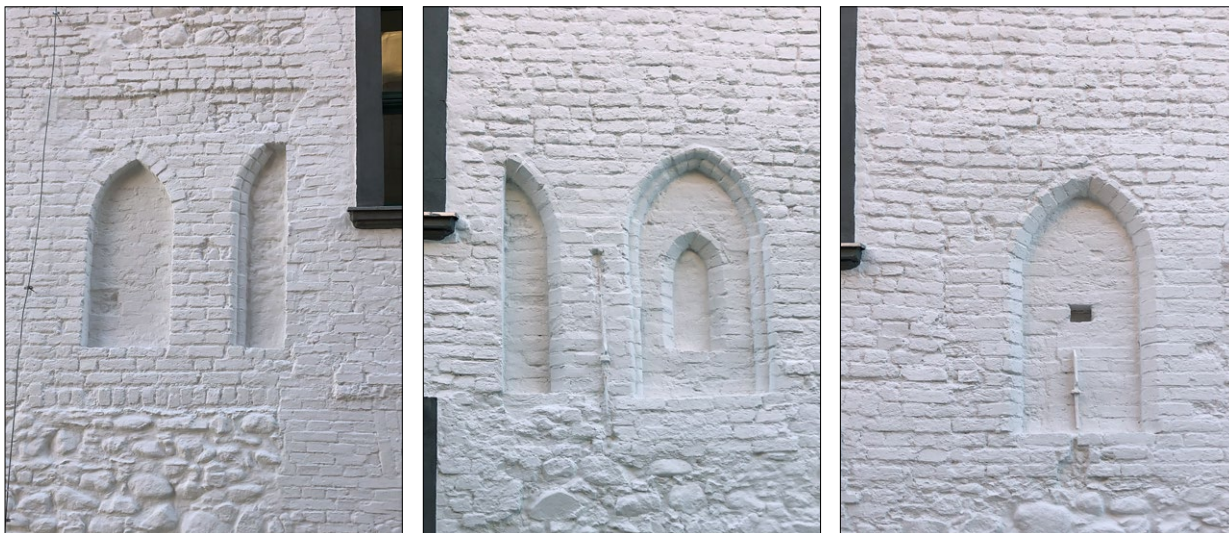
Ryc. 8 a, b, c. Elewacja północna, detale gotyckiego wystroju piętra, stan po pracach; fot. autor.

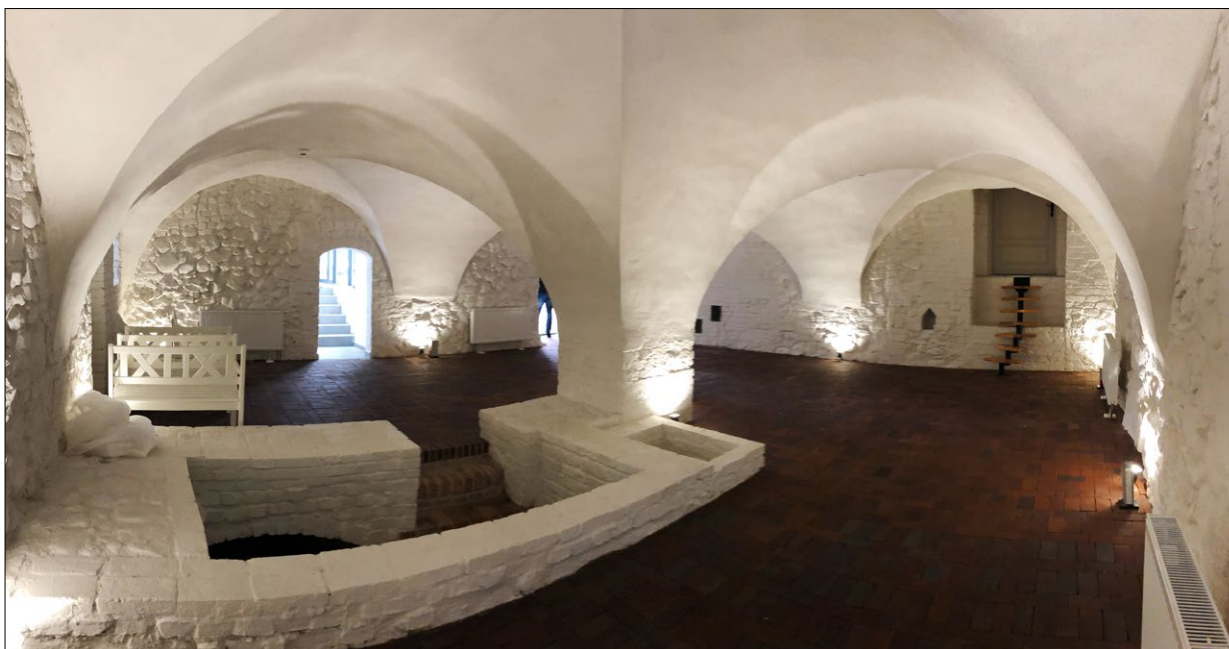
Ryc. 9. Parter, pasmo wschodnie, wnętrze sali renesansowej ku zachodowi, stan po pracach; fot. autor.

Fig. 9. Ground floor, eastern bay of the building, interior of the Renaissance room towards the west, condition after the renovation works; photo by the author.

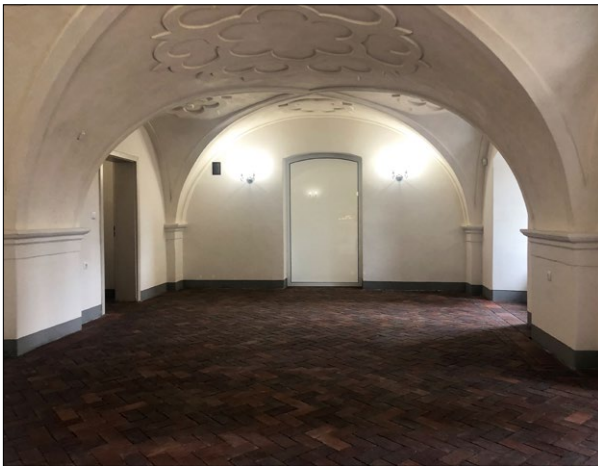
Ryc. 10. Parter, pasmo środkowe, wewnątrz sali barokowej traktu tylnego ku wschodowi, stan po pracach; fot. autor.

Fig. 10. Ground floor, middle bay of the building, interior of the baroque room of the back part of the building to the east, condition after the renovation works; photo by the author.

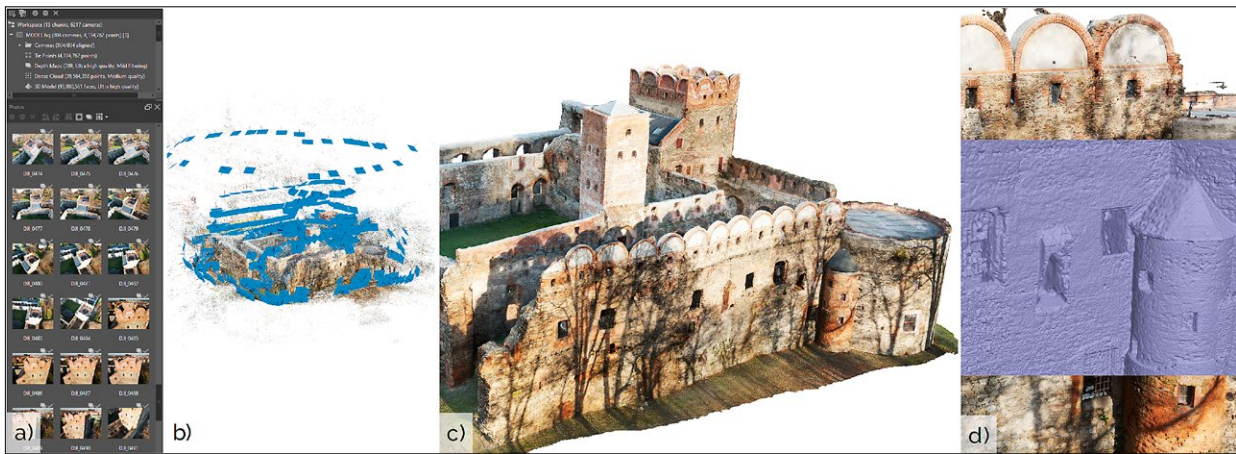
Ryc. 3. Ząbkowice Śląskie – odwzorowanie fotogrametryczne; a) zestaw 804 zdjęć z drona wykonany przez poinstruowany zespół studentów, czas prac terenowych ok. 4 godzin; b) koordynacyjna chmura punktów – obliczenia pozycjonujące ok. 6 godzin; c) uzyskany model siatkowy, czas obliczeń ok. 16 godzin, obszar 100x100 m; d) fragment jakościowego odwzorowania tekstur i geometrii; oprac. autor.

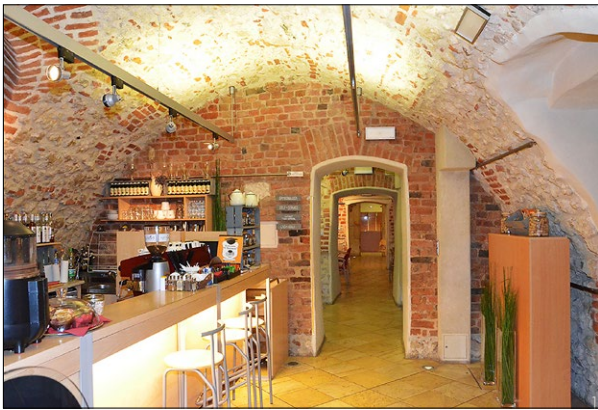
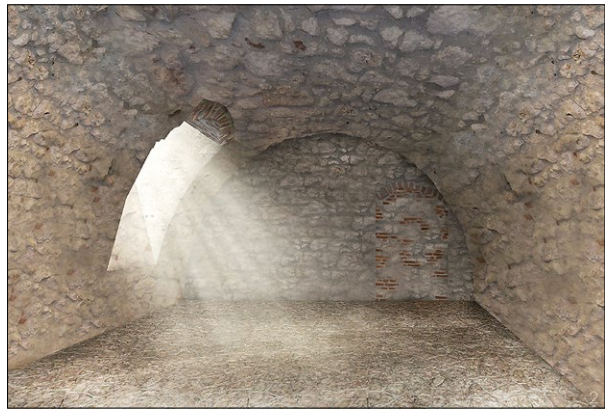
Ryc. 1, 2. Przyziemie narożnej „wieży” podzielone wtórnie na dwie piwnice. Stan obecny i wizja przeszłości; oprac. A. Kulig, J. Dziewoński.  
Fig. 1, 2. The cellar of the corner “tower,” remodeled as divided into two spaces, present and historical state, by A. Kulig, J. Dziewoński.

The present-day corner cellar was remodeled and divided (in the nineteenth century) into two spaces of uneven size. They feature a nineteenth-century brick wall that obscured the view of the original southern stone wall. The entrance was probably located from the side of the property’s courtyard. The vault on the lowermost level of the tower was a result of remodeling, probably carried out in the early sixteenth century. The vault was probably set into grooves cut into older walls—the eastern and western ones. It is a vault constructed from quarry-faced stone, oriented along the north–south axis, with two window lunettes in the eastern wall.

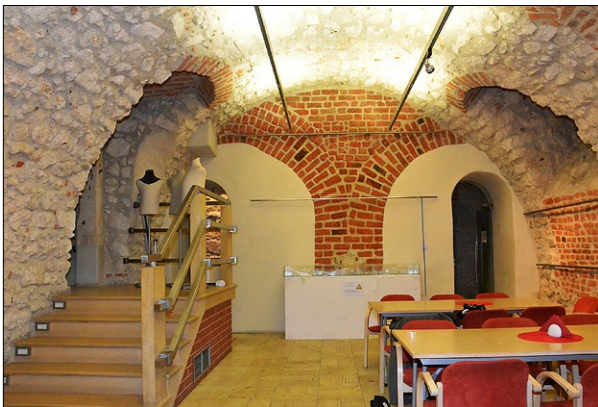
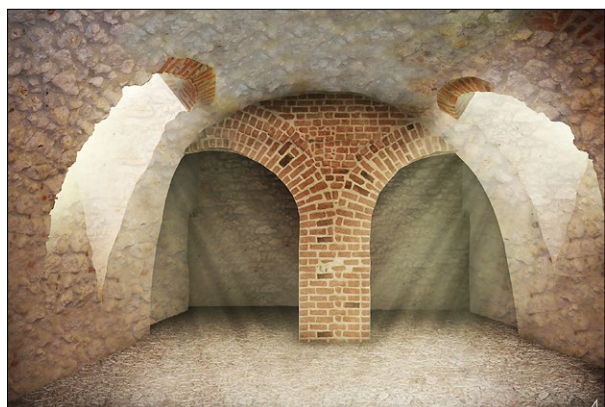
Ryc. 3, 4. Przyziemie skrzydła zachodniego, widok w kierunku ściany zachodniej. Stan obecny i wizja przeszłości; oprac. A. Kulig, J. Dziewoński.  
Fig. 3, 4. The lowermost level of the western wing, view towards the western wall, present and historical state, by A. Kulig, J. Dziewoński.

Tomkowicz 1900, p. 115]. Around the mid-fifteenth century, a western wing with a rectangular floor plan was added to the corner “tower.” The wing faced Św. Anny Street with its longer side. The building’s lowermost level, or rather its cellars (its level was relatively shallow), was built from roughly hewn stone; in its western part, two brick arcades supported by a central column were used to arrange a narrow space, probably used for circulation. We do not know the original height of this level (cellar), which was originally covered by a ceiling supported by wooden beams; perhaps the larger, eastern space was higher than it is now, and the arcades had supported some sort of gallery (above the smaller cellar space), open towards an extraordinarily high main chamber. It was not a minor space, either in Pęcherz’s house and in the first Collegium building of the restored University. Most probably, the openings in the larger cellar space—an entrance in the southern wall and windows in the northern one—are original, and the lunettes of the later vaults were adapted to them. The vault of the larger cellar space was built as part of a remodeling project—probably around the year 1400; it should be tied with the first “university” phase. It is a barrel vault built from roughly hewn stone, with its longitudinal axis along the east–west direction, with three lunettes with highly placed windows in the northern wall, a low-placed entrance lunette from the courtyard in its southern wall (eastern axis) and a lunette that probably acted as a window and now is an entrance to a corridor underneath the arcade (western axis). The openings in the walls are probably original, and the lunettes from the later-built vault were adapted to them. The lunettes were built with sectional panels, constructed using high hand-shaped bricks. In the northern wall these are three window lunettes, while in the southern wall there are two: one for an entrance from the courtyard and one from a corridor (following a set of stairs), underneath the arcade (Fig. 5, 6). In the smaller cellar space (deeper, with brick arcades), there is a surviving barrel vault from around 1400, its lower part made of stone and the upper from brick. It is relatively highly placed, following the north–south axis.

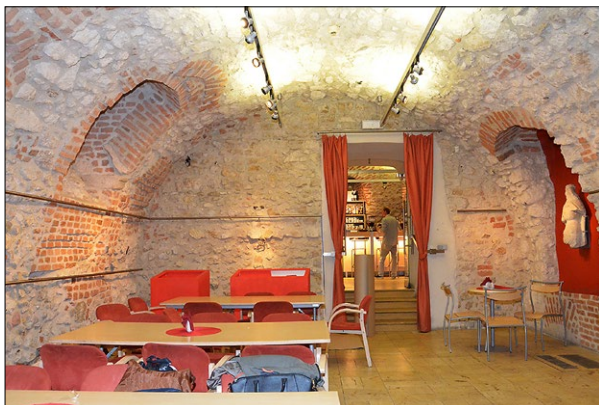
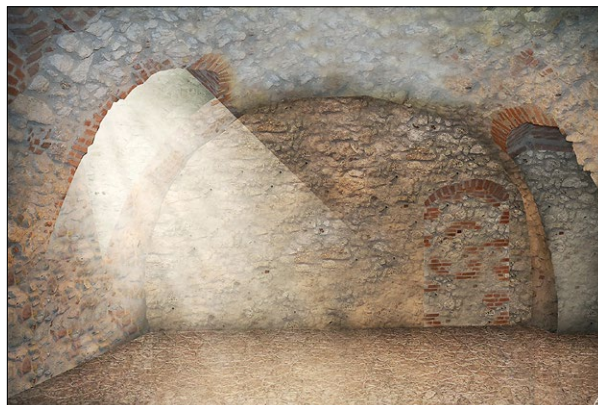
Ryc. 5, 6. Przyziemie skrzydła zachodniego, widok w kierunku ściany wschodniej. Stan obecny i wizja przeszłości; oprac. A. Kulig, J. Dziewoński.  
 Fig. 5, 6. The lowermost level of the western wing, view towards the eastern wall, present and historical state, by A. Kulig, J. Dziewoński.

łożoną lunetą wejścia z podwórza przy ścianie południowej (oś wschodnia) oraz lunetą prawdopodobnie okna, dziś wejścia do korytarza pod krużgankiem (oś zachodnia). Otwory w murach są prawdopodobnie pierwotne, a lunety późniejszego sklepienia do nich dostosowano. Lunety zbudowano z odcinkowymi sklepienkami, używając do ich budowy wysokich cegieł palcowanych. Przy murze północnym są to trzy lunety okien, przy murze południowym zaś dwie lunety: wejścia z podwórza oraz luneta wejścia do korytarza (po schodkach), pod krużgankiem. W mniejszej piwnicy (w głębi, za ceglany arkadami) zachowane jest sklepienie kolebkowe z około roku 1400, w dolnej partii kamienne, a wyżej ceglane. Jest ono stosunkowo wysoko osadzone, na osi północ-południe.

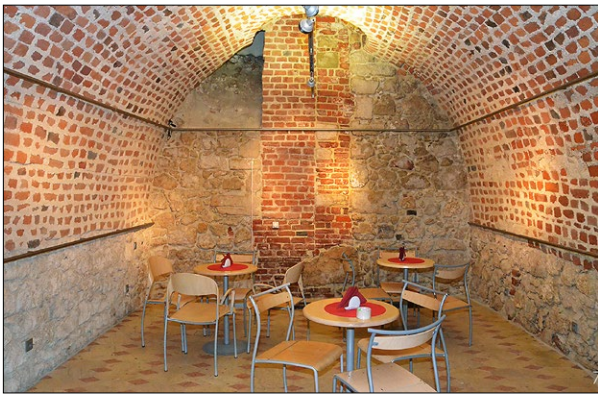
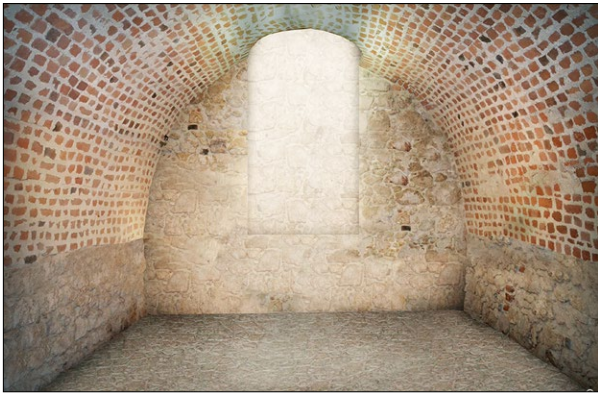
Ryc. 7, 8. Piwnice skrzydła wschodniego, łączącego dom Pęcherza z kurią Piotra Gerhardsdorfa, widok na ścianę wschodnią z oknem od ul. Jagiellońskiej. Stan obecny i wizja przeszłości; oprac. A. Kulig, J. Dziewoński.

Fig. 7, 8. The cellars of the eastern wing, that connect "Pęcherz's house" with Piotr Gerhardsdorf's curia, view of the eastern wall with a window facing Jagiellońska Street, present and historical state, by A. Kulig, J. Dziewoński.

The cellars of the eastern wing, which connects "Pęcherz's house" with Piotr Gerhardsdorf's curia [see Sławiński, Hiżycka 1999–2000, p. 32], built as a part of enclosing the courtyard, were constructed between 1462 and 1492, namely between the two great fires, which also affected the Collegium Maius. Three cellars were constructed (they were cellars right from their inception), as indicated by the system of entrances from the courtyard and highly placed windows (facing Jagiellońska Street). These cellars were vaulted from the very beginning. The cellars were constructed in the years 1469–1492. They feature brick barrel vaults oriented along the east–west axis, with lunettes for windows and entrances—from the street and from the courtyard—near the eastern and western walls.

In the first cellar from the south (it is located near the cellar adapted into a stairwell), the window that faces Jagiellońska Street was originally located on the axis of the eastern wall. A brick lunette supported by an arch in the shape of a rather irregular oval terminated at its location. The old window was walled up in the nineteenth century. A narrow niche that ended with a window at its top and was present below the lunette was walled up (flush to the wall face). Originally, it was

flush with the wall surface). A new window was constructed to the southern side of the original one, analogously as in the previous cellar (from the south; Fig. 8).

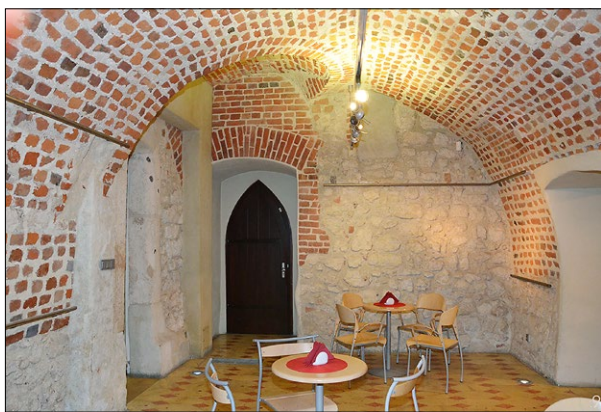
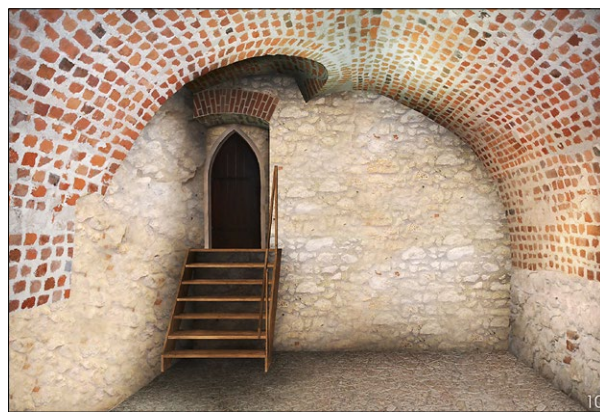
Ryc. 9, 10. Piwnice skrzydła wschodniego, widok na ścianę zachodnią z wyjściem na dziedziniec. Stan obecny i wizja przeszłości; oprac. A. Kulig, J. Dziewoński.

Fig. 9, 10. Cellars of the eastern wing, view of the western wall with an exit to the courtyard, present and historical state, by A. Kulig, J. Dziewoński.

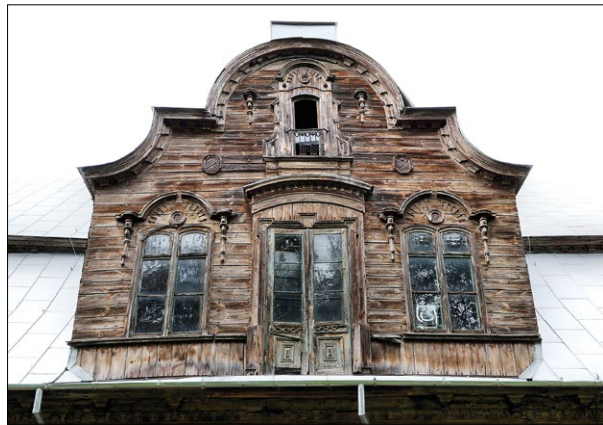
Ryc. 2. Elewacja facjaty wschodniej; fot. M. Warchoń 2020.

Fig. 2. Eastern dormer; photo by M. Warchoń 2020.

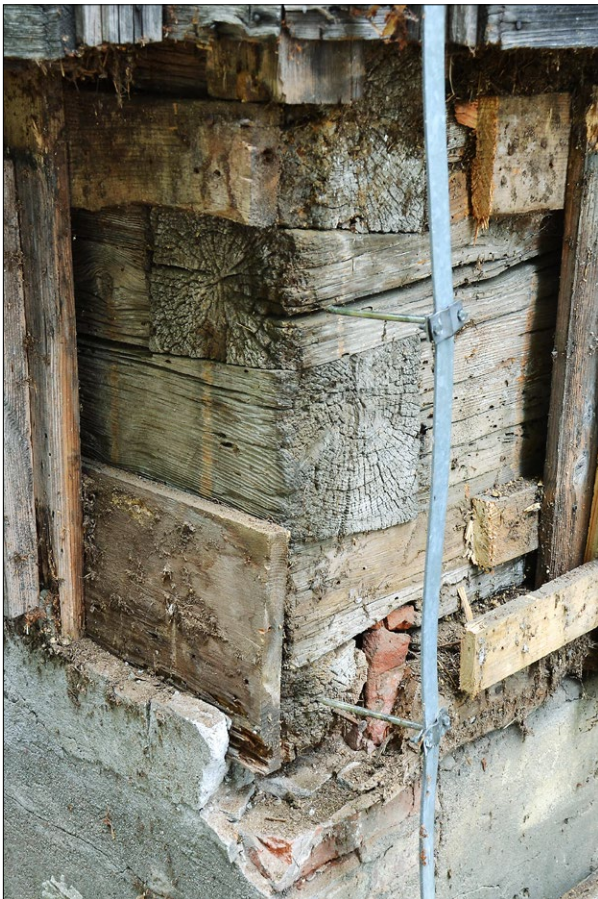
Ryc. 3. Odkrywka południowo-zachodniego węgła zrębu ścian zewnętrznych; fot. E. Zawaleń 2020.

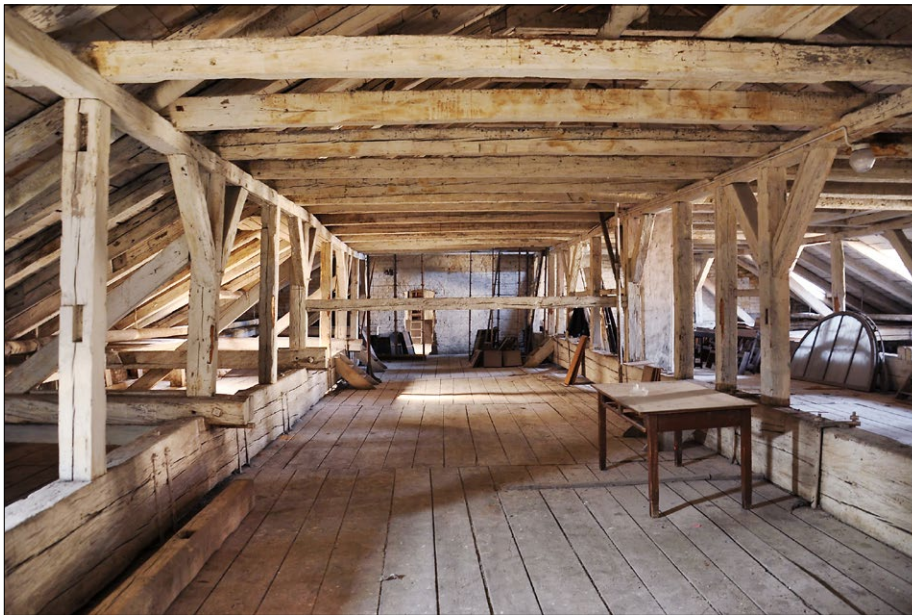
Ryc. 2. Więźba dachowa z 1846, widok w kierunku południowym; fot. U. Schaaf 2021.  
 Fig. 2. Roof structure from 1846, view towards the south; photo by U. Schaaf 2021.

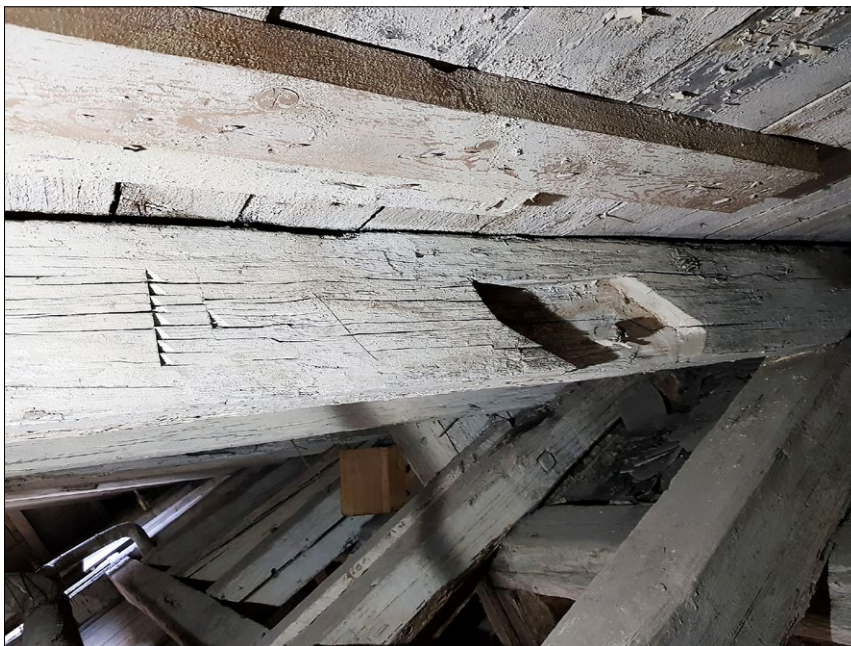
Ryc. 9. Wrocław, budynek przy ul. Szewskiej 49, więźba dachowa z 1846, wtórnie użyte elementy, krokiew z gniazdem nakładkowym i znakiem montażowym w formie trójkątów przy kresce; fot. U. Schaaf 2021.

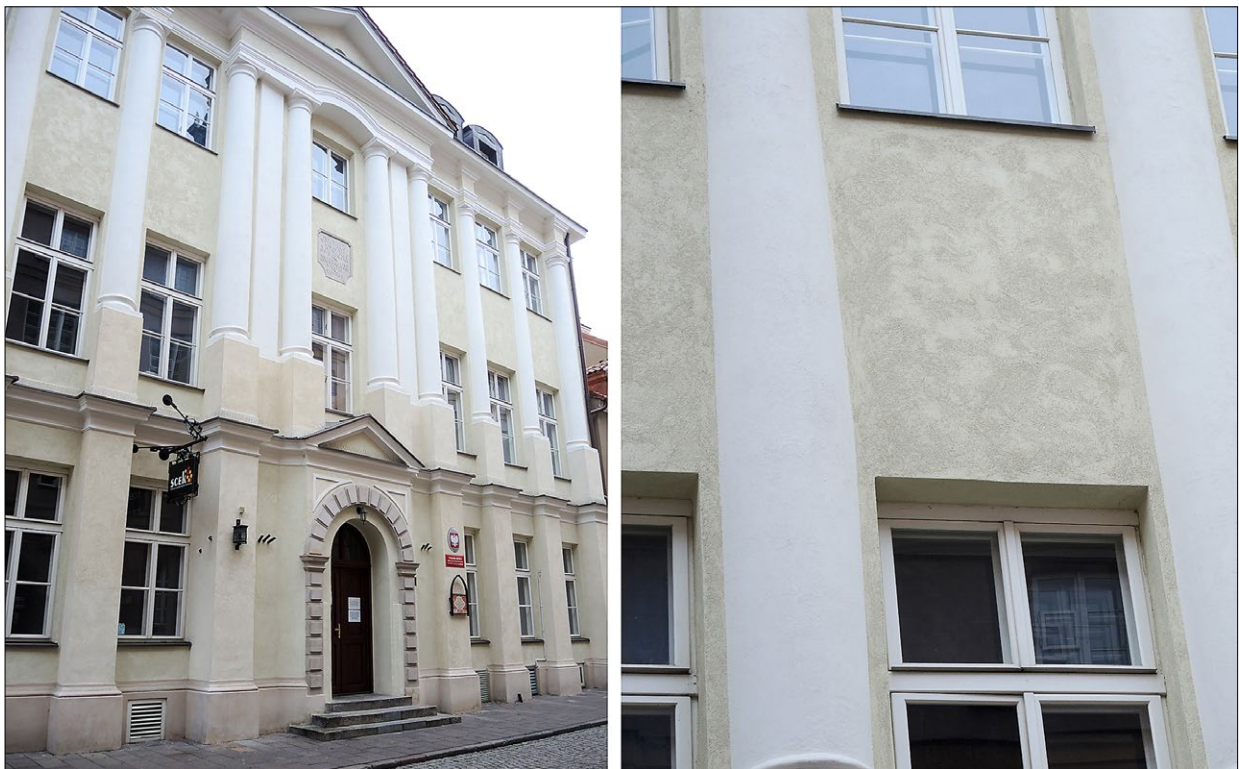
Fig. 2. The building at 4 Jezuicka Street showing the use of mass-colored plaster, 2020; photo by T. Sawicki.

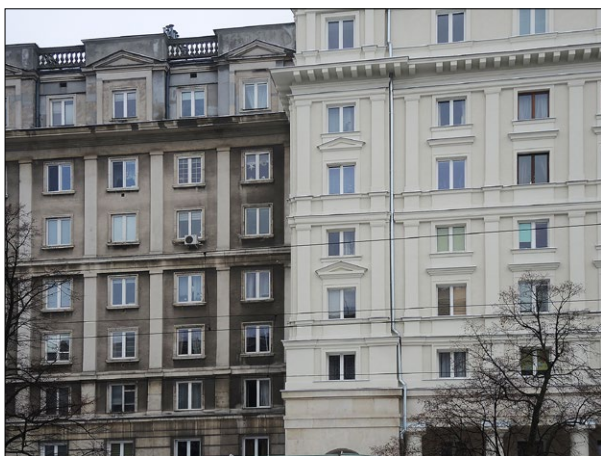
Fig. 4. The building at 24 Świętojska Street, the elevation from the side of Andersa Street, next to it, the building is not renovated, 2020; photo by T. Sawicki.

The practice of applying colored plaster on facades has been adopted not only on the buildings of the Old and New Towns. Another example is the building at Świętojerska Street in the district of Muranów. Sandstone elements were cleaned, while the plasters were covered with a layer of mortar with the addition of mica, while the pilasters and cornices were painted with light-colored paint. The effect of the renovation may be pleasing, but nevertheless this method of renovation of the facade causes an excessive load on the underlying plasters and repeating it in the future will blur the architectural divisions of the structure. It is difficult to understand why work was

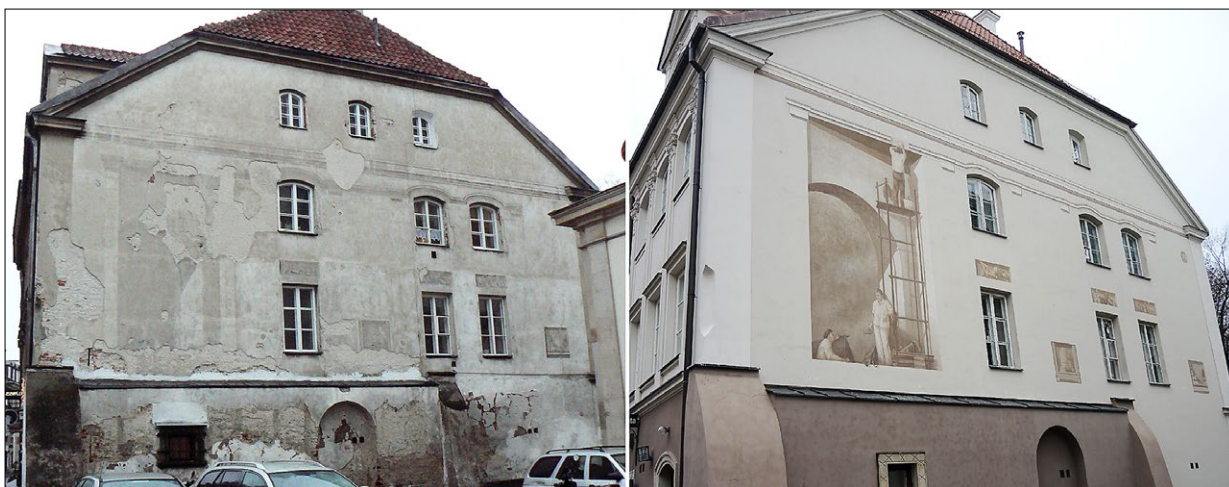
Ryc. 7. Kamienica przy ul. Freta 12, ściana szczytowa przed skuciem tynków oraz po narzuceniu nowych tynków i rekonstrukcji malowidła B.T. Urbanowicza; fot. T. Sawicki.  
 Fig. 7. The tenement house at 12 Freta Street, the gable wall before plastering and after applying new plasters and reconstruction of the painting by B.T. Urbanowicz; photo by T. Sawicki.

A very unfortunate decision was also made in 2013 regarding the mural on the gable facade of the tenement house at 12, Freta Street. This was a beautiful composition by Bohdan T. Urbanowicz from 1954 depicting bricklayers, commemorating the reconstruction of the Old Town. The painting, which had a historical and symbolic significance, was by this time in a extremely poor condition—the plasters were largely degraded, the figural part of the representation was destroyed. However, the remaining elements of the composition had survived: decorative panels and painted architectural elements. Conservation and reconstruction of this decoration would be difficult, but feasible. Instead, it was decided to chisel the plaster of the entire wall down to the underlying brickwork and apply a totally new layer on which an ineffective reconstruction of the painting was made. A comparison of one decorative panel of this decoration before the chiseling and after recreating it on the new plaster shows the qualitative difference between these completely mismatched paintings. In this case, we are dealing with a complete failure to respect the postulate of preserving the authenticity of the object, which is the basis for all conservation activities.

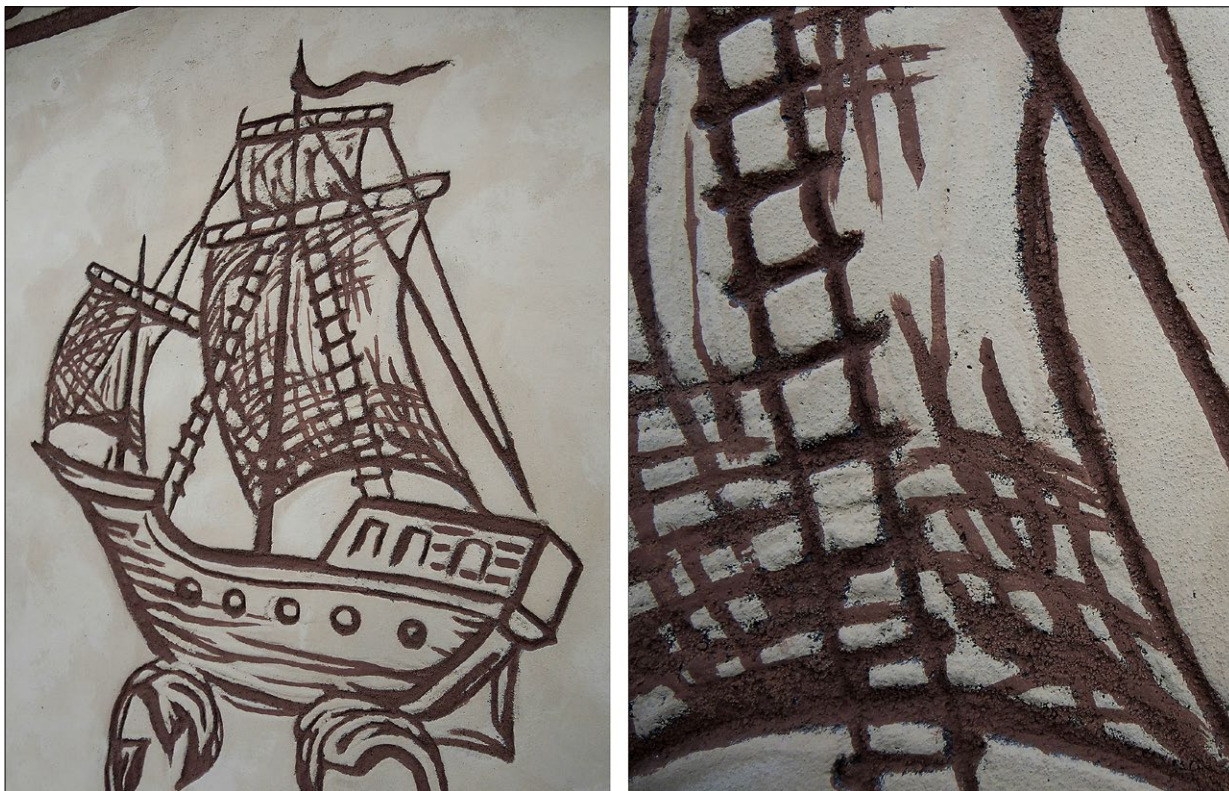
Fig. 9. Fragment of sgraffito on a tenement house at 9 Szeroki Dunaj Street, after renovation, 2020; photo by T. Sawicki.

An example is the renovation of the sgraffito on the facade of the tenement house at 9 Szeroki Dunaj Street. The decoration was irreversibly changed during the conservation in 1972: the bottom plaster layer became considerably darkened, and the top light plaster was covered with a thin layer of sand-lime mortar [“Dokumentacja konserwatorska, kamienica ul. Szeroki Dunaj 9” 1972]. It was impossible to restore the original color scheme. Therefore, it was necessary to decide to leave the dark color of the underlying plaster, and merge the top layer to the light grey color, exposed in places where cleaning was successfully carried out. Meanwhile, the sgraffito was repainted—the bottom layer with a brown color with a red shade, and the top layer with a light cream color. The criterion for choosing the colors was the design by Witold Miller, the author of the sgraffito, kept at the Museum of the Academy of Fine Arts in Warsaw. However, it is not certain whether the final version of the sgraffito was compatible with this project, because the localized invasive investigation of the surviving mural does not confirm this.<sup>13</sup> As a result of careless repainting, the engravings were flooded with paint in many places, which were then marked with brown-red lines. The missing parts of the mermaid medallions on the second floor, in the strip between the windows, and the backgrounds of figures symbolizing various professions, placed on the

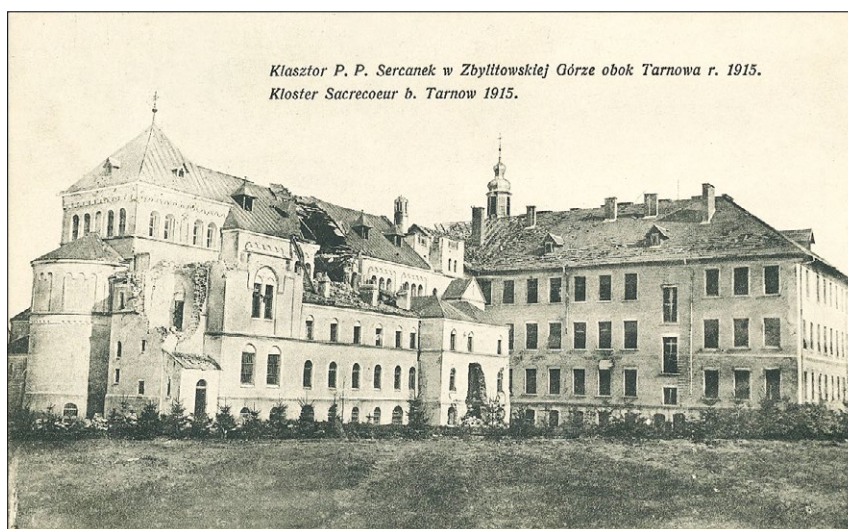
Fig. 4. The building of the Sisters Servant to the Most Sacred Heart of Jesus in Zbylitowska Góra near Tarnów, damaged as a result of wartime operations; [www.polona.pl](http://www.polona.pl).
